CONDITIONS ASSESSMENT REPORT

*Architecture  
Planning  
Conservation*

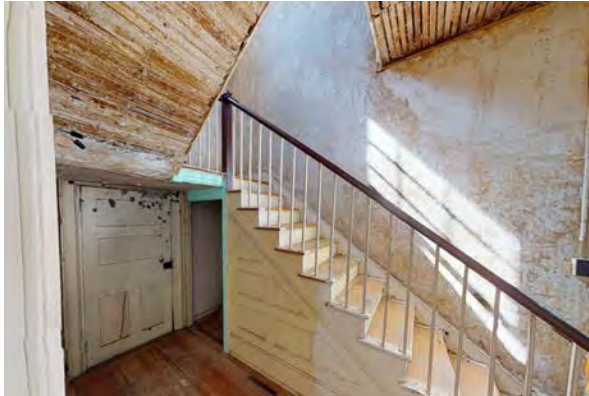
*West Building. South door of foyer and stair, both defining features.*

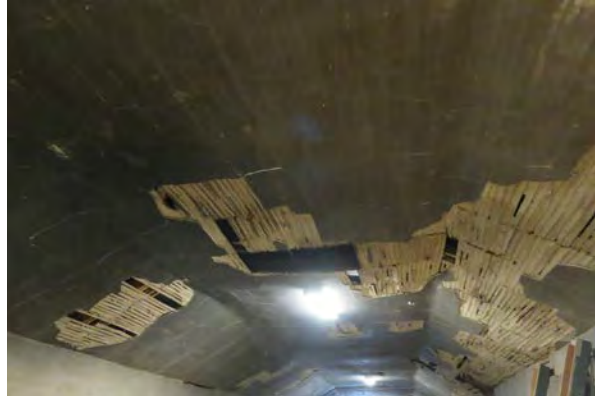
*East Building. Plaster ceiling at the attic. Note staining and large areas of missing plaster and missing lath.*

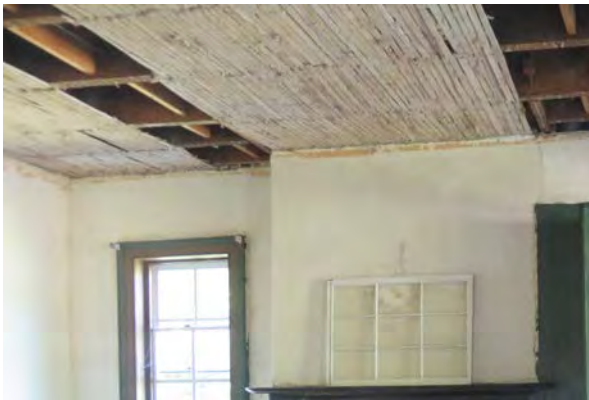
*West Building. Missing ceiling in the first floor west room. Note the ghosting from a crown molding.*

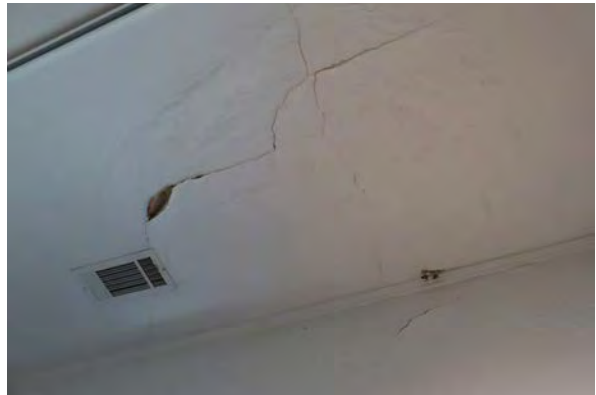
*East Building. Water damaged ceiling and wall in southeast room at the second floor.*

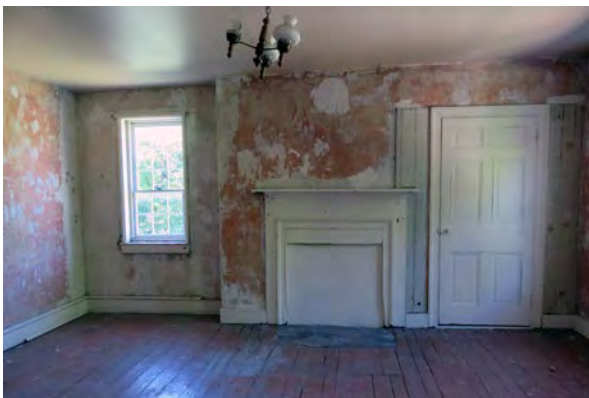
*West Building. Second floor room.*

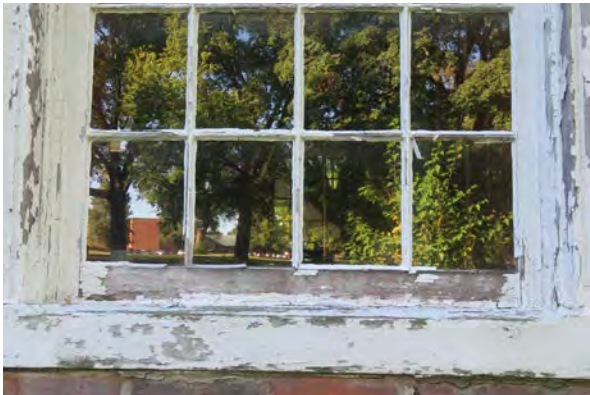
*Paint and glazing putty deterioration at a north elevation window.*

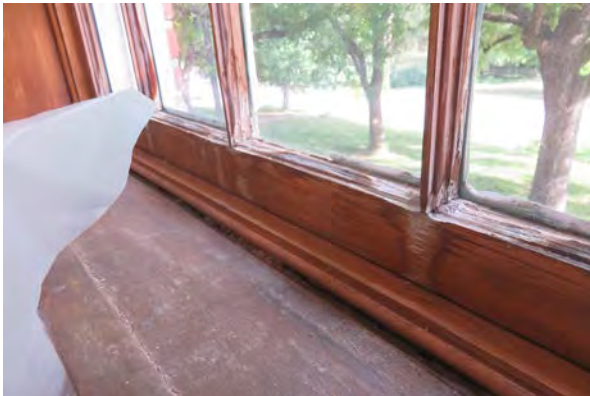
*North Building. Water damage at new sash, deteriorating finish at window sill.*

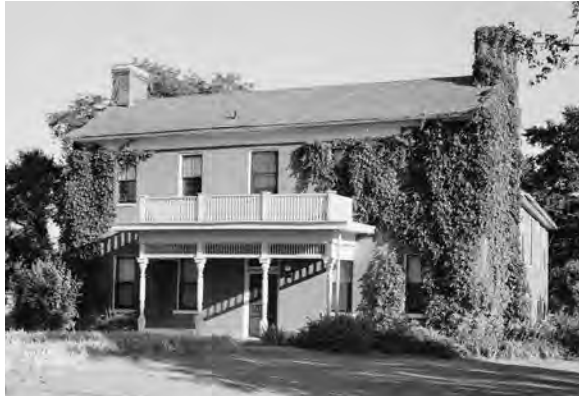
West Building, 1940, Photo courtesy of HABS KAN-3 by Lester Jones. [<https://www.loc.gov/item/ks0018/>]

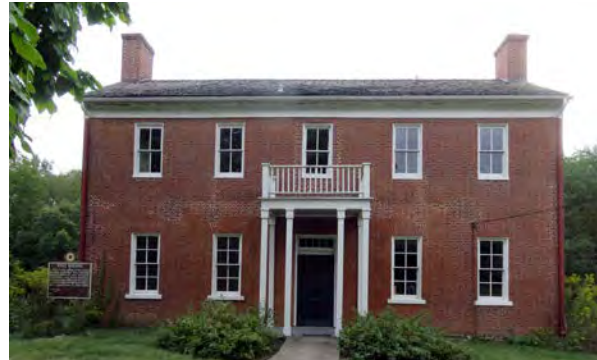
*West Building, north elevation*

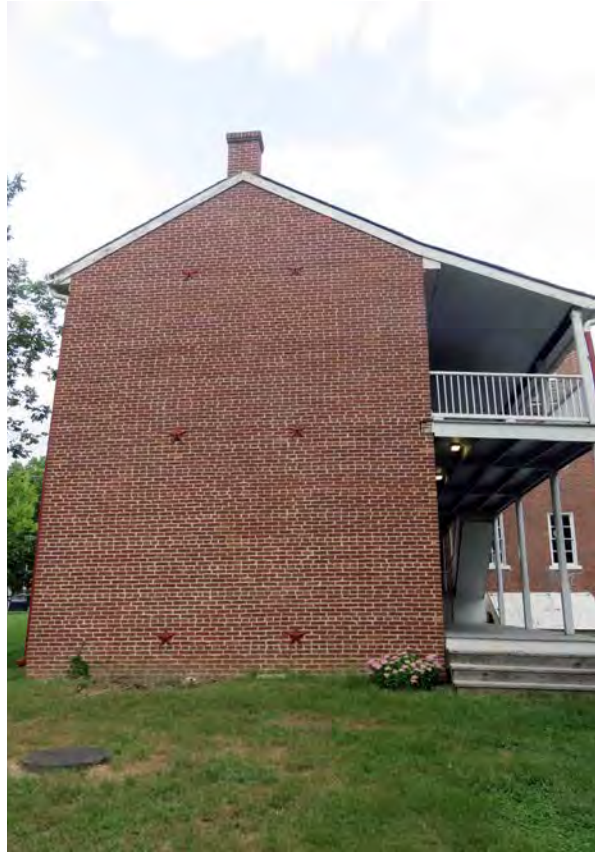
*South elevation, rear addition*

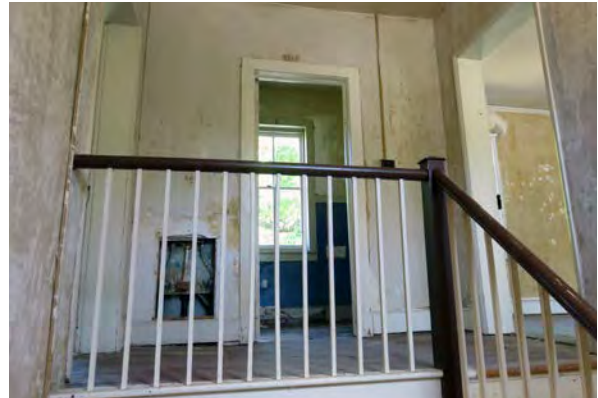
*Landing at second floor*

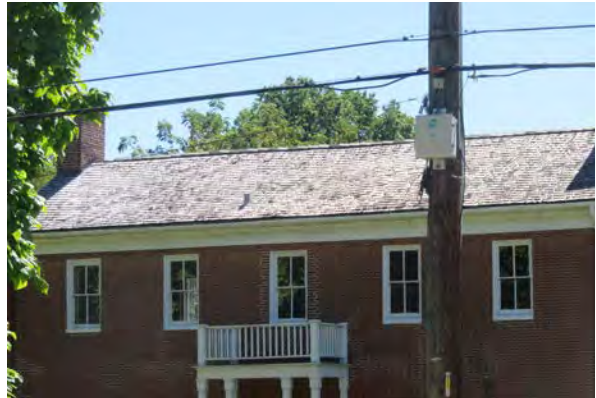
*Roof at north elevation.*

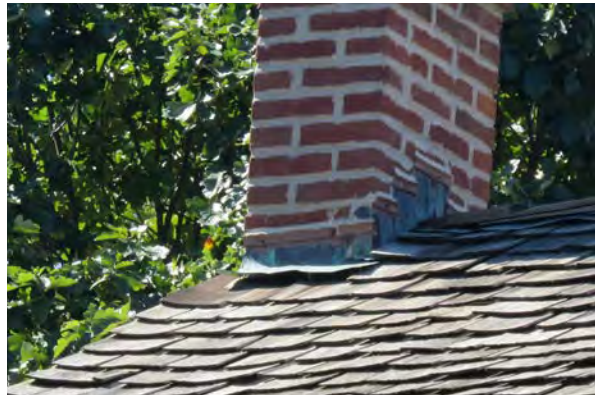
*Lifting flashing at south chimney. Note the deteriorated sealant.*

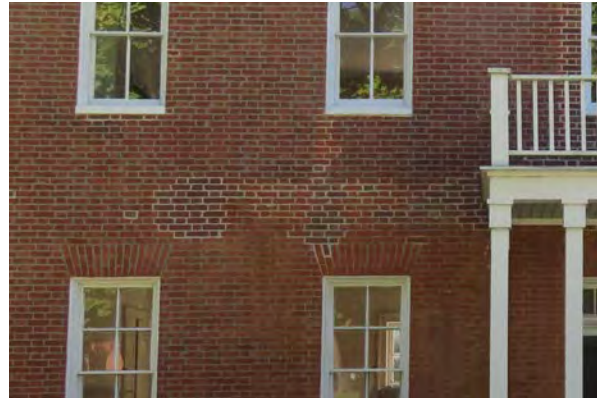
*Flemish bond at north elevation.*

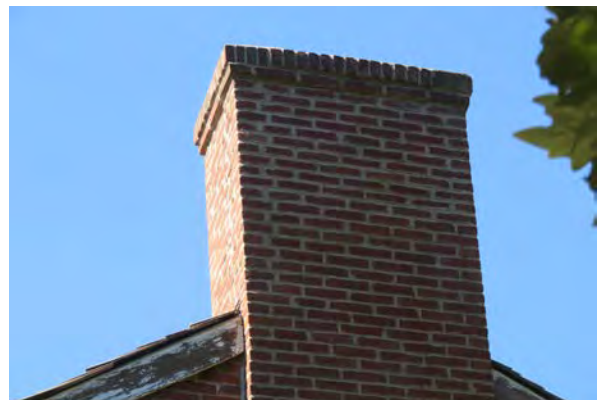
*Open joints at east chimney. Note deteriorated paint at fascia panels.*

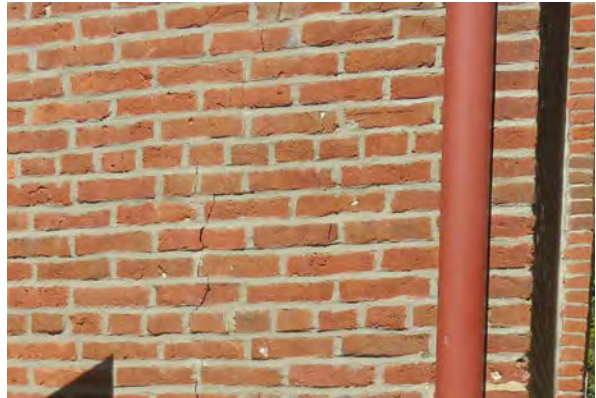
*Masonry crack at southeast corner.*

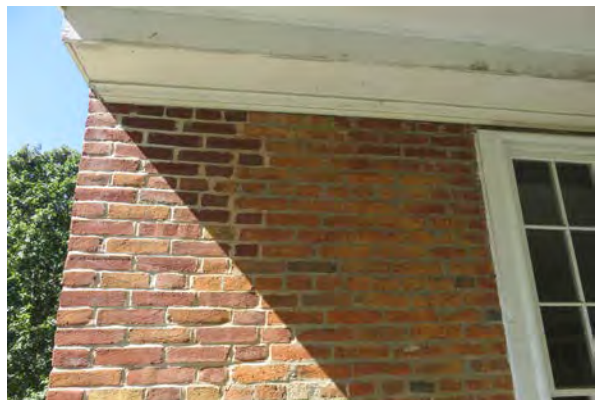
*Repointing at an area of brick replacement. Note the different colors of mortar and the yellow coating on the bricks to the right.*

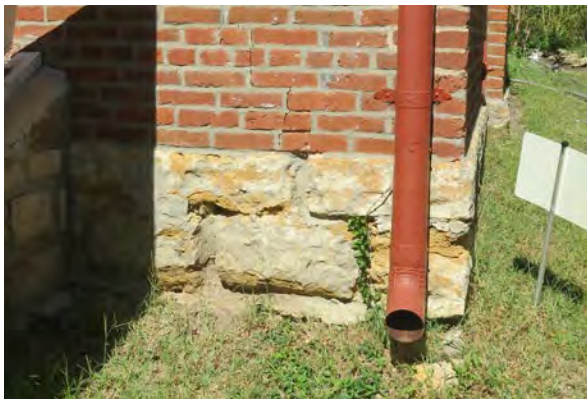
*Open joints and previous repointing efforts at the ashlar foundation.*

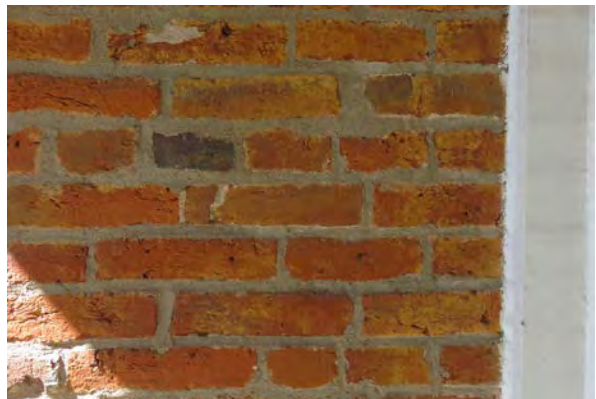
*Brick with traces of yellow coating.*

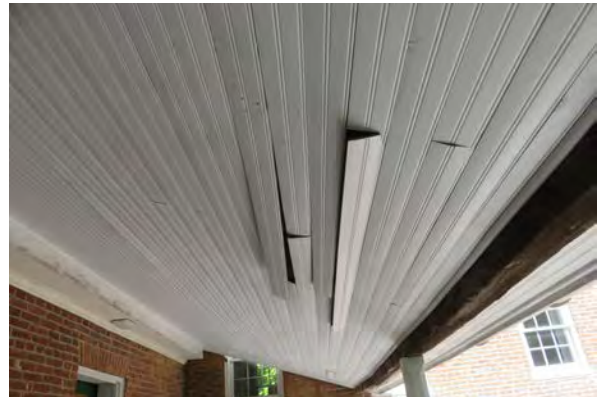
*Falling cladding at the second floor of the east porch.*

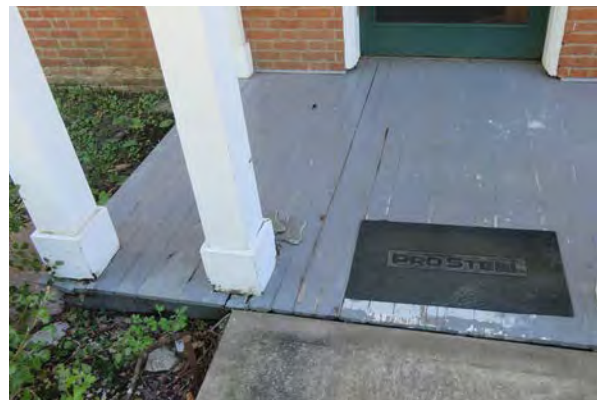
*Paint and wood deterioration at north porch. Note the open seams in the column bases. These conditions are typical of both porches.*

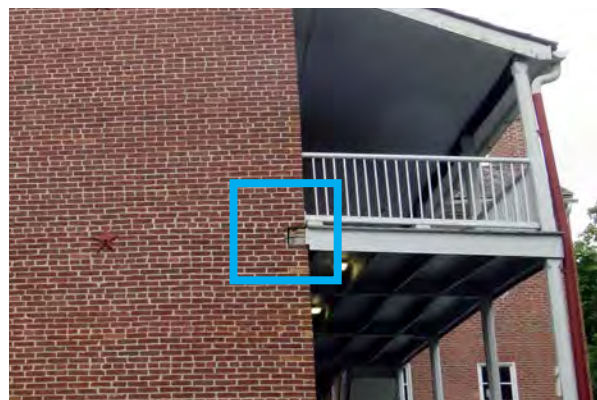
*Exposed joist pocket, outlined in blue.*

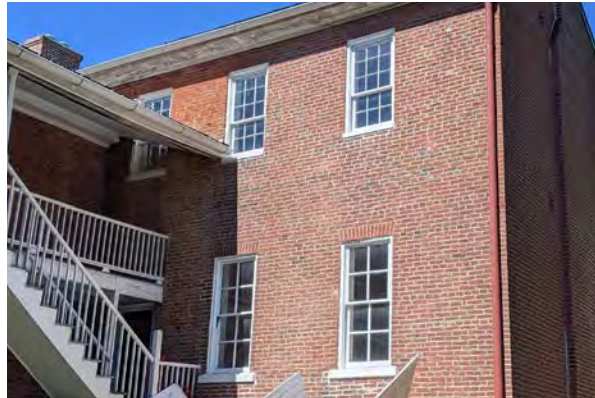
*Window pattern on the rear of the original structure.*

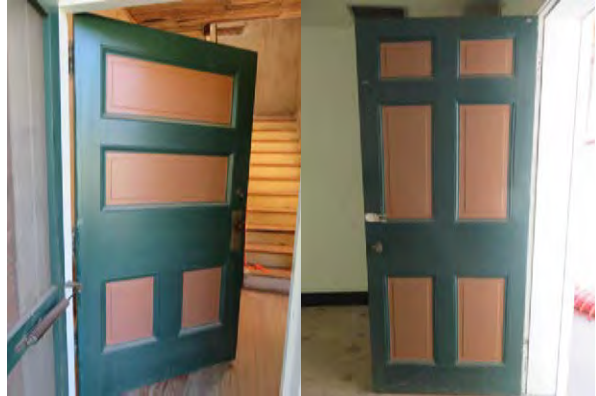
*Two styles of exterior doors.*

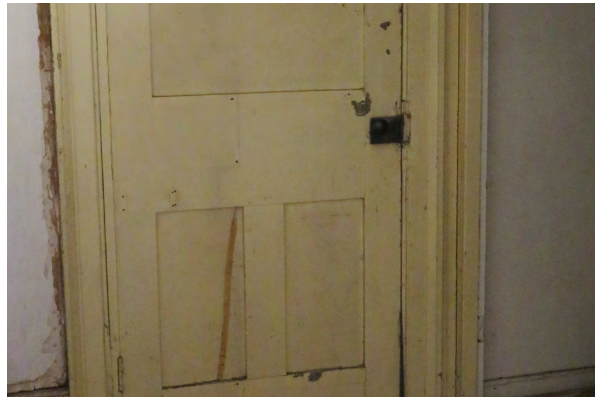
*Old box lock on the porch door. Note the repaired wood check in the lower left panel.*

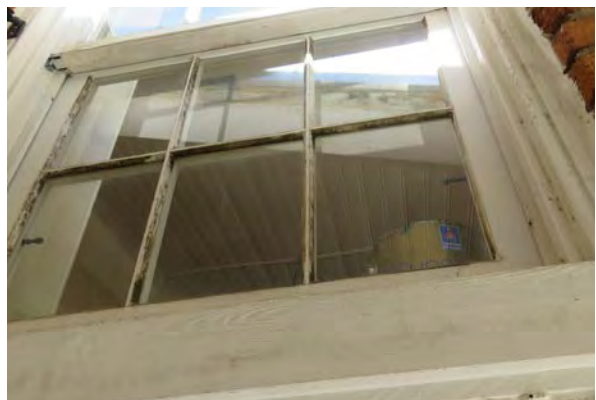
*Deteriorated paint and glazing material at a window on the south elevation.*

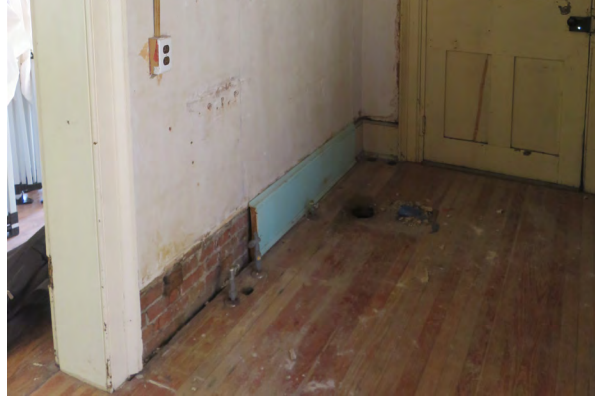
*Exposed portion of brick wall below plaster in foyer.*

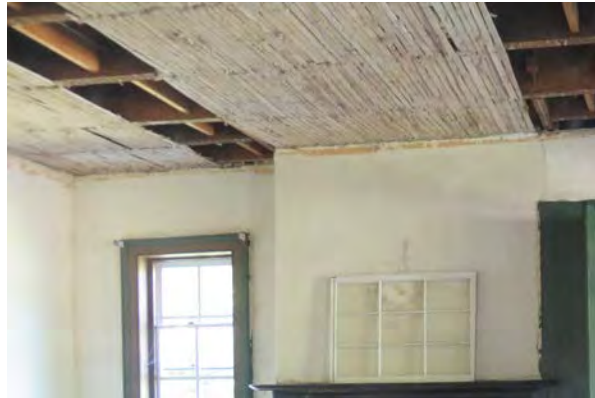
Missing ceiling in the west room. Note the ghosting from a crown molding.

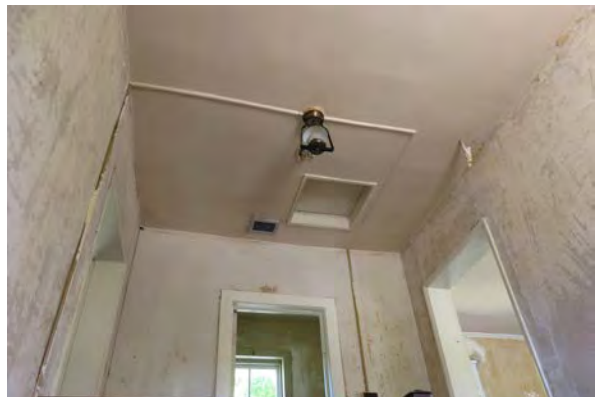
Wallboard ceiling at the second floor landing. Note the surface mounted conduit. The east and west walls of the foyer and stair are solid masonry with no room wiring behind the plaster.

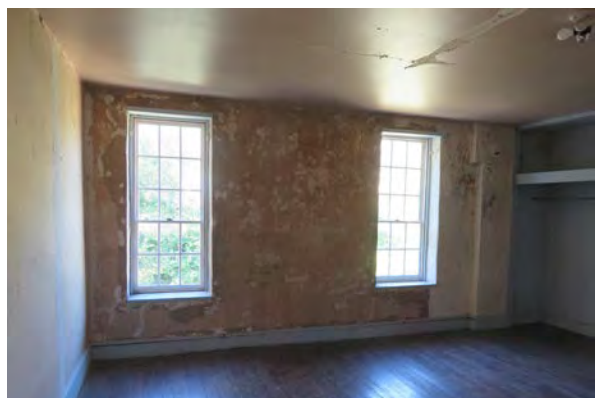
Plaster wall at second floor room in the rear addition. Note the ceiling damage and unfinished drywall on the left.

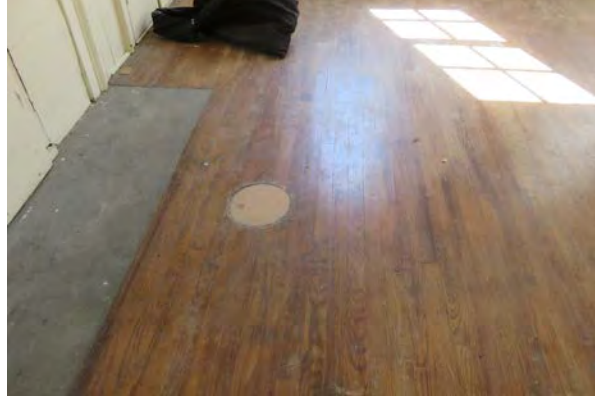
*Repaired hole in the floor of the first floor east room.*

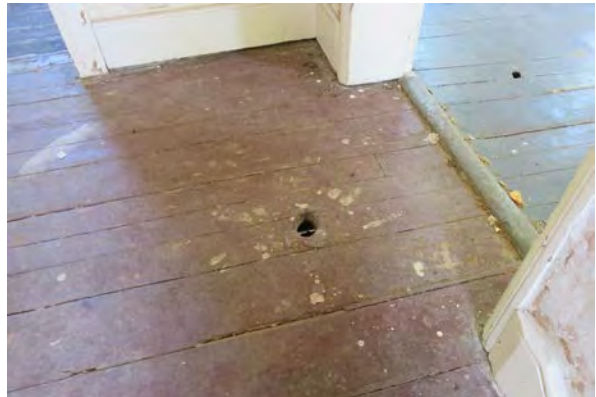
*Holes in the floor of the second floor landing and second floor east room.*

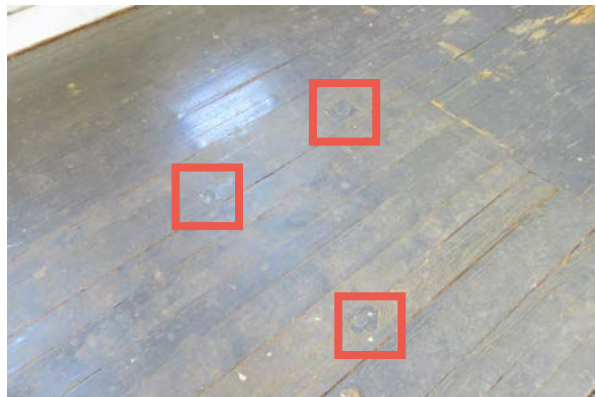
*Repaired holes in the floor in the second floor east room, outlined in red.*

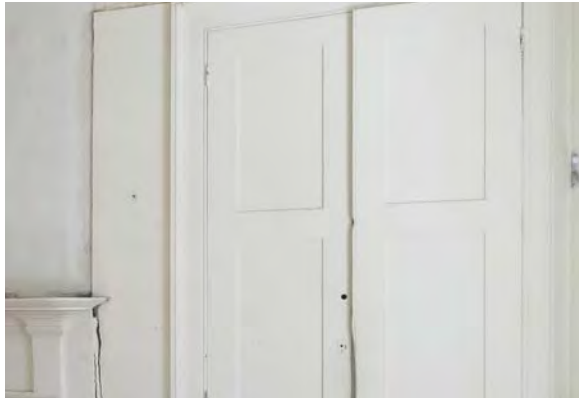
*Missing and over-painted hardware on built-ins.*

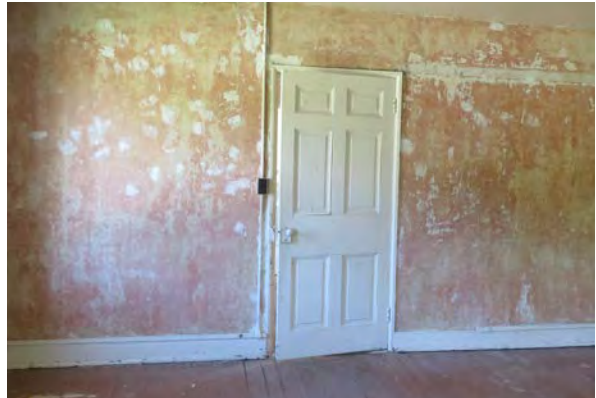
*Six panel door with box lock, in the second floor west room, leading to the stair landing.*

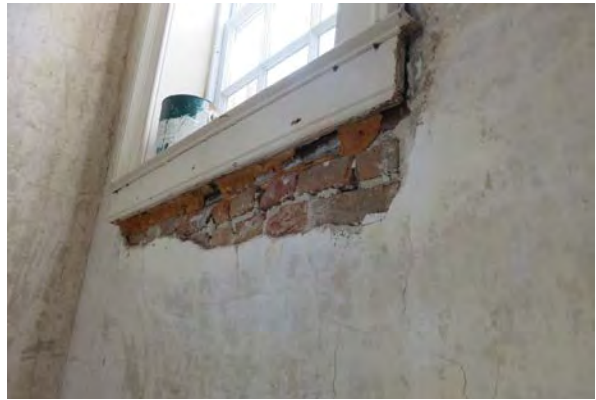
*Plaster damage and exposed masonry below stairwell window.*

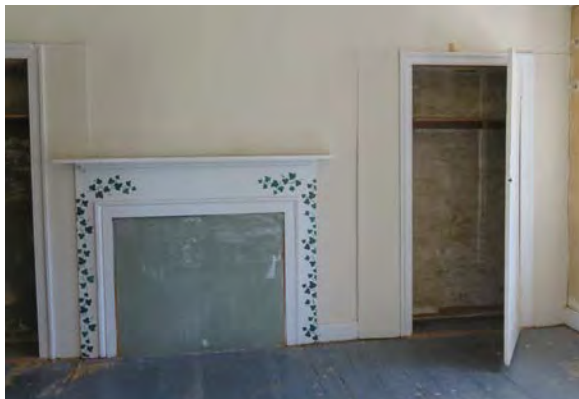
*Covered fireplace in second floor east room. Note that the built-ins may have been converted to closets relatively early, as this is a mortis and tenon panel door, not a modern hollow door.*

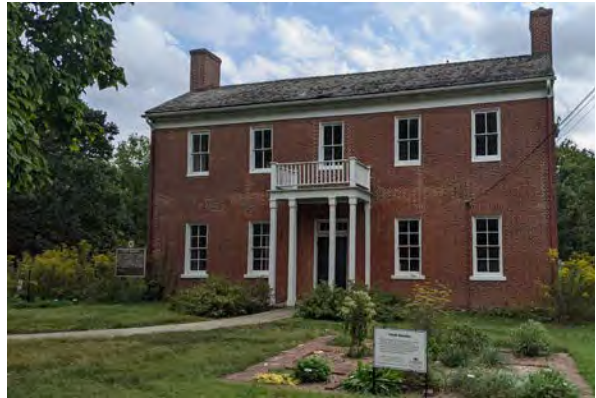
*Garden and butterfly way-stations flank the concrete path to the main entrance.*

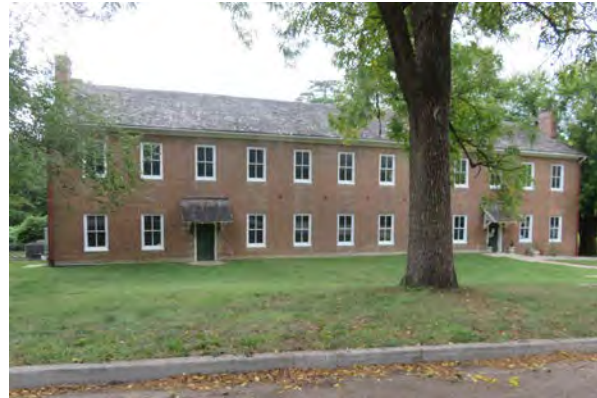
*East Building, east elevation*

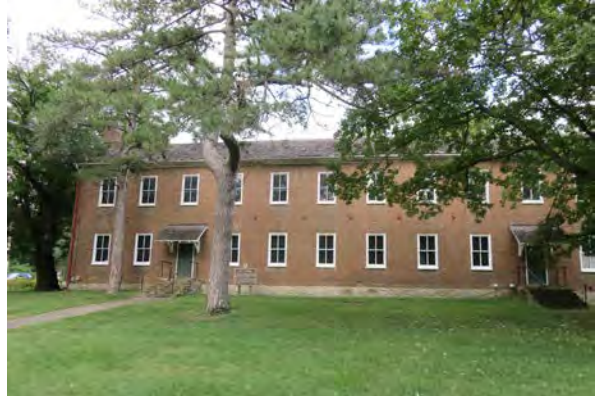
*East Building, west elevation.*

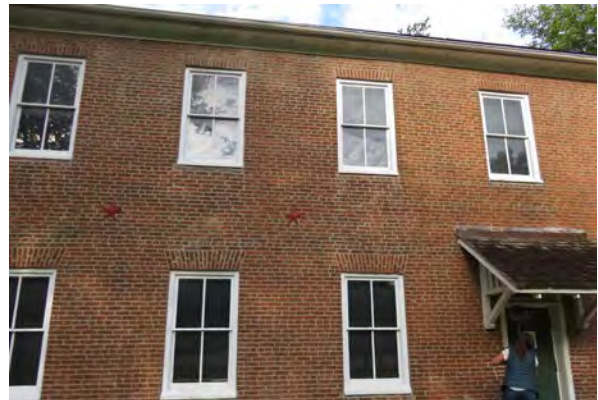
*Exterior brickwork, with splayed lintels over windows.*

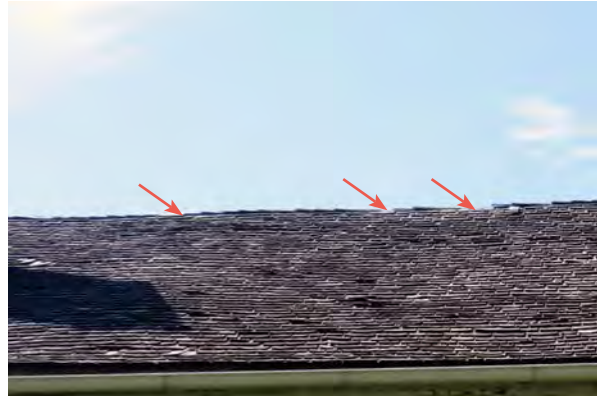
*Sections of missing shingles at the ridge beam, indicated with red arrows.*

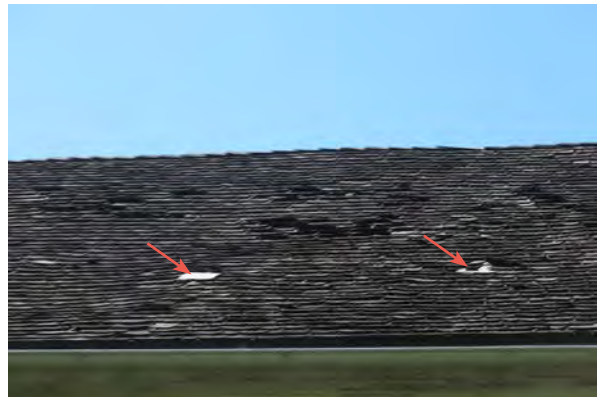
*Lifting and curling shingles. Note the plastic sheets used instead of shingles, indicated with red arrows.*

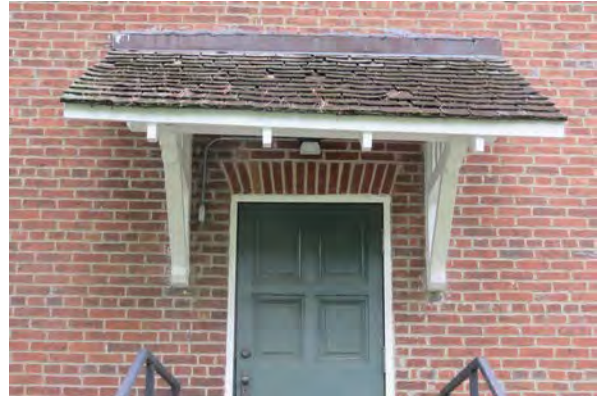
*Sagging awning at the northwest entrance. Note the failed sealant at the flashing above the awning.*

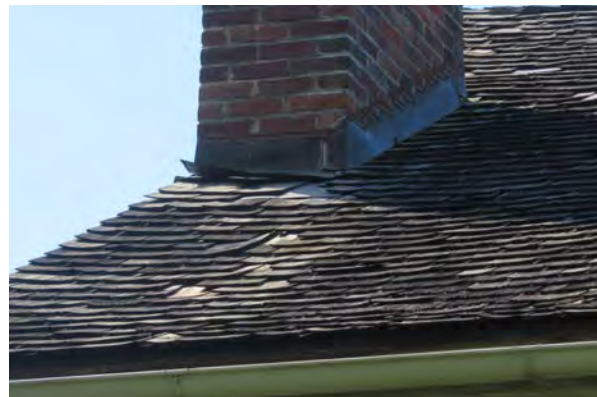
*Lifting flashing and deteriorated sealant at southeast chimney.*

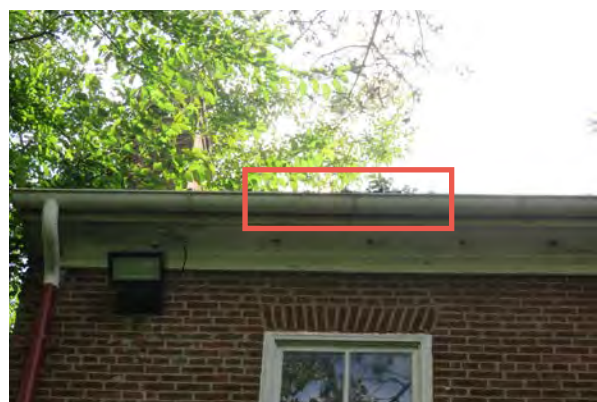
*Pine needle and plant buildup in gutter visible from ground level, outlined in red.*

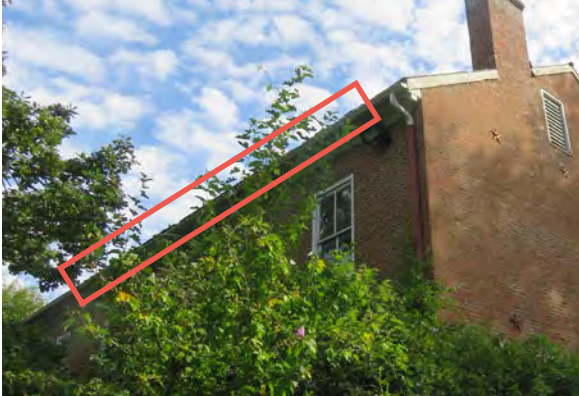
*Area of damaged gutter outlined in red. Note you one can see the edges of the shingles due to the bent gutter.*

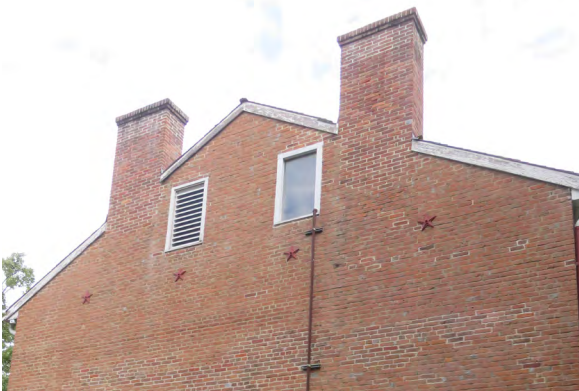
*Deteriorated paint at south fascia.*

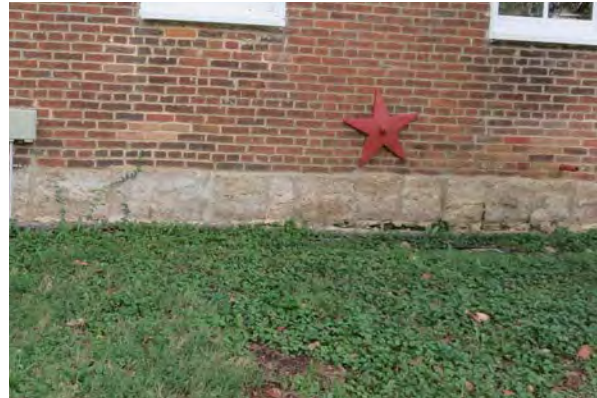
*Open joints and plants growing in the gaps of the stone foundation.*

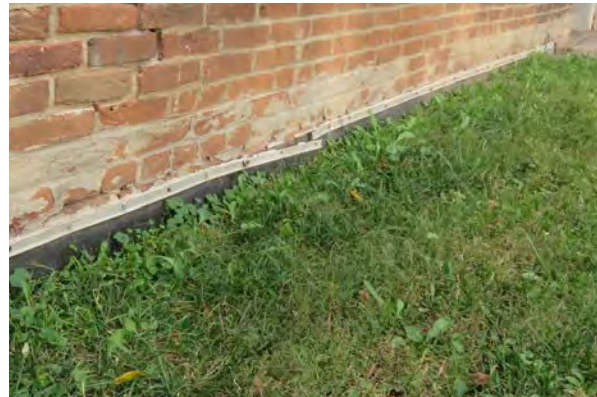
*Location of the waterproofing membrane pulling away from the masonry.*

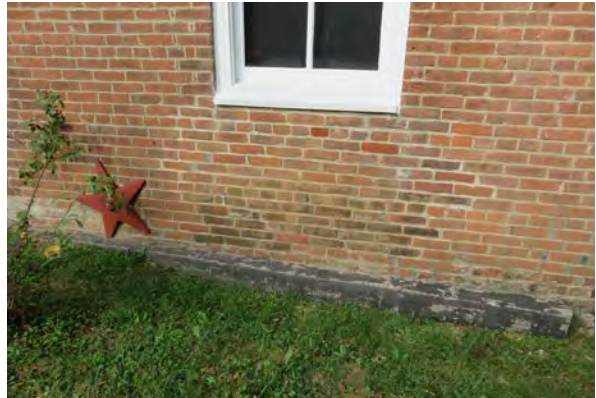
*Area of repointing and brick replacement at the east elevation.*

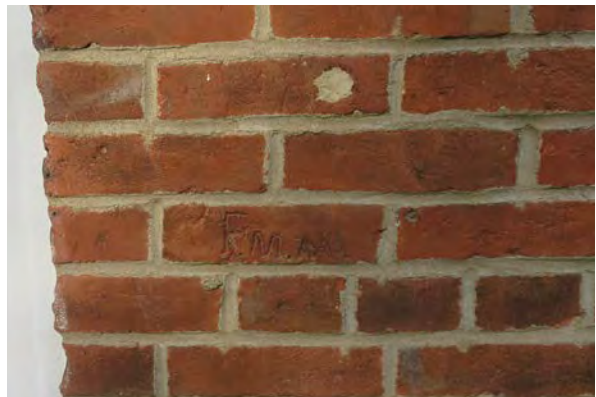
*Scratched initials in the brick face. Note the mortar patch a few courses above.*

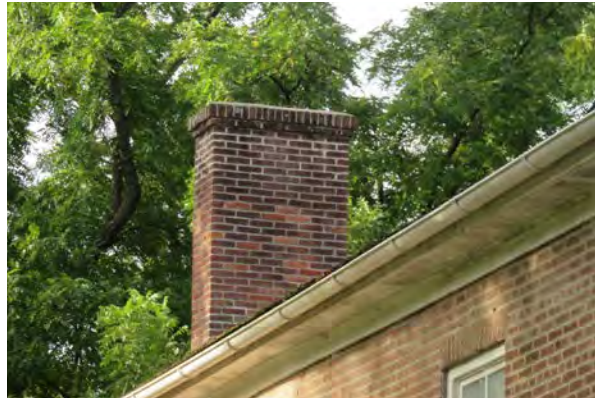
*Heavily weathered and cracked mortar cap on the southeast chimney. This condition is typical of the other chimneys as well.*

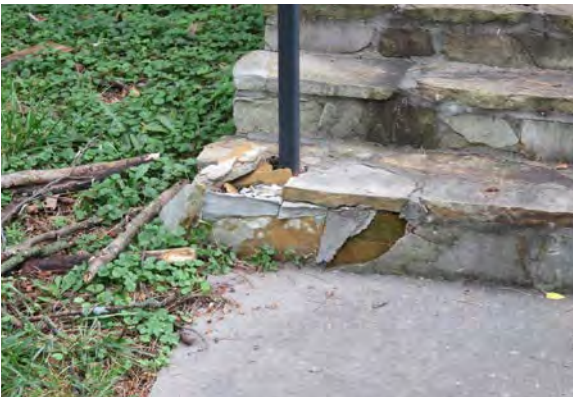
*Damaged corner of northwest stair. Note that this area has been repaired, but that repair has failed.*

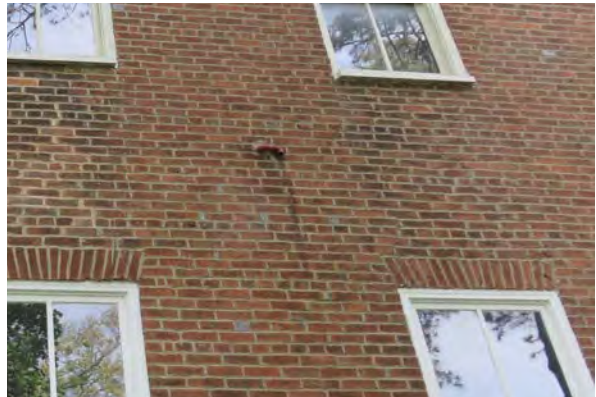
*Pipe at the north end of the west elevation leaking an unknown substance down the brick.*

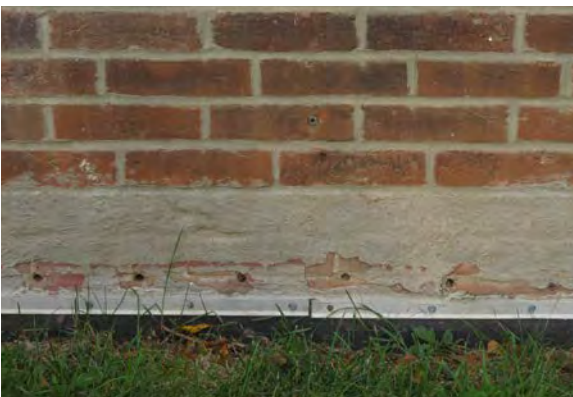
*Cement parging and abandoned anchor holes above waterproofing membrane at the east elevation.*

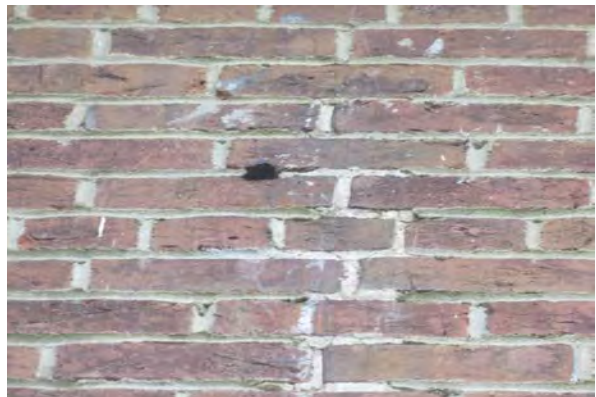
*Old anchor and staining from old downspout location.*

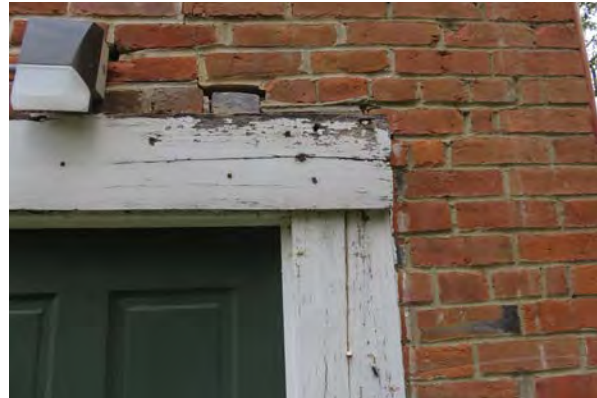
*Wood and paint deterioration at kitchen door.*

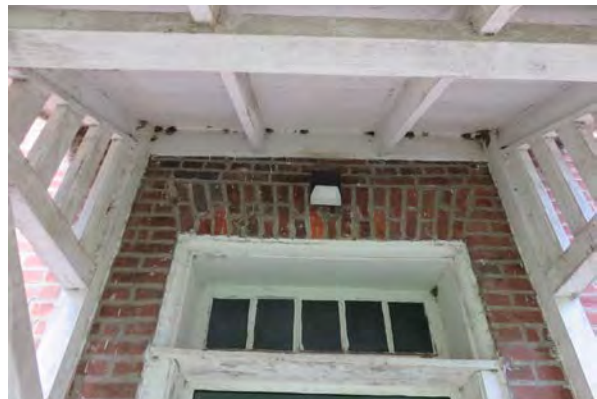
*Deteriorated paint and insect nests below awning. Note the overpaint and deteriorated paint at the door surround.*

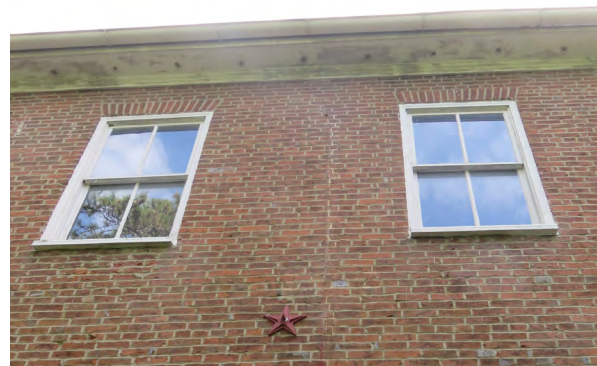
*Second floor windows at the west elevation, showing signs of paint deterioration at bottom rail of upper sash.*

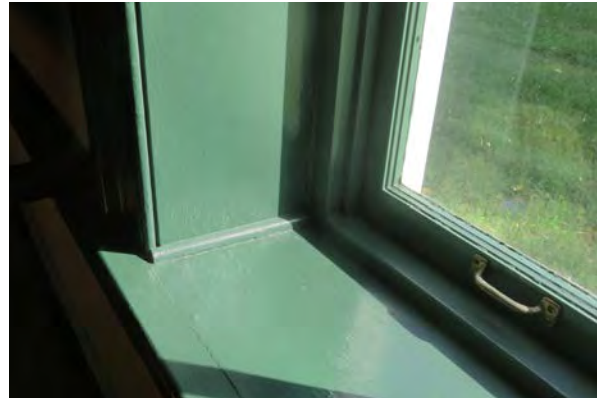
*Windows on the first floor did not open and appear to be painted shut. It is unclear if this was intentional or due to high temps and humidity during the site visit.*

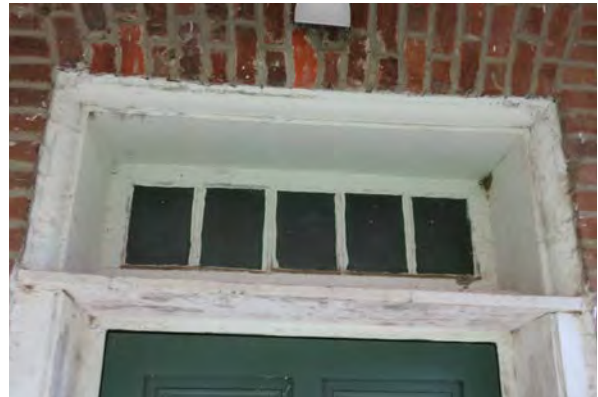
*Deteriorated sealant at door surround.*

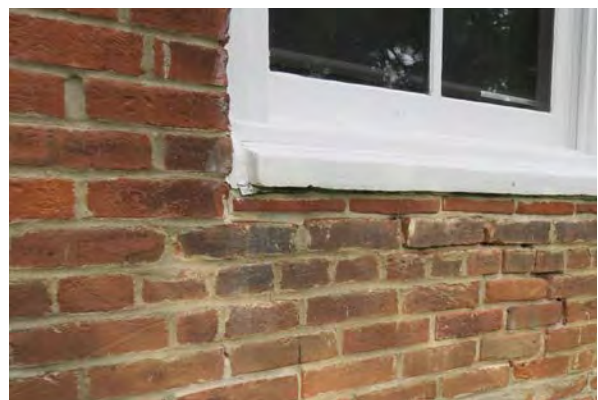
*Sealant at window frame.*

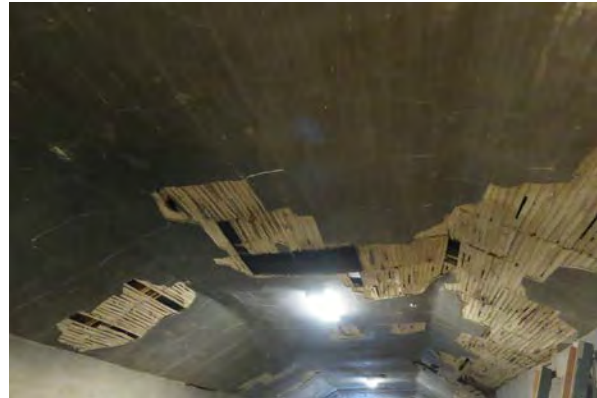
*Plaster ceiling at the attic. Note staining and large areas of missing plaster and missing lath.*

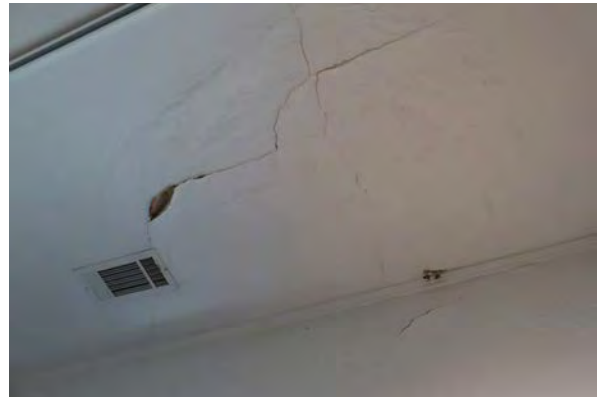
*Water damaged ceiling and wall in southeast room.*

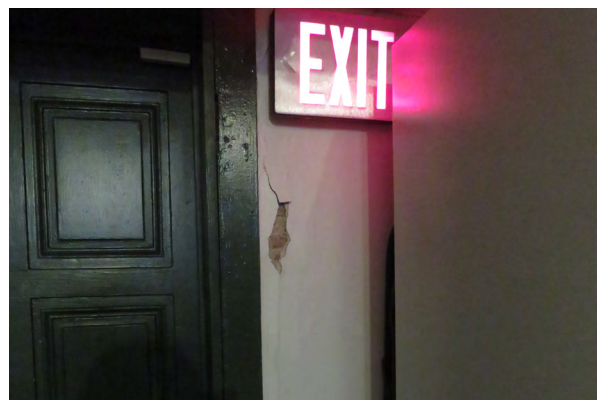
*Plaster cracking at northwest door. The masonry is exposed in this area, and multiple previous finishes are visible.*

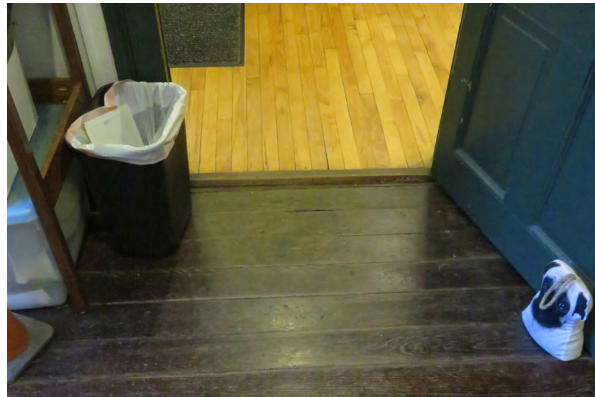
*Transition between north foyer (above) and office (below) floors.*

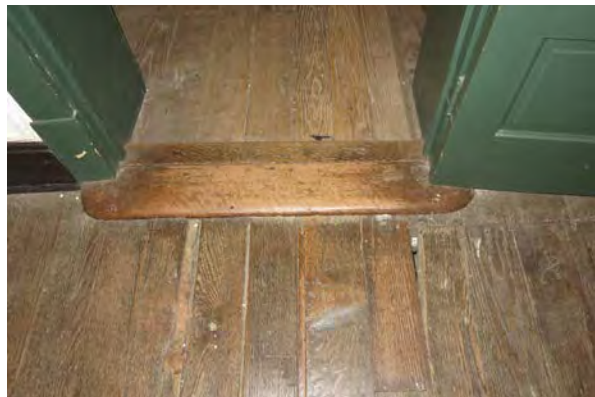
*Large threshold at south door to second floor central room, due to floor slope. Note the broken board to the right.*

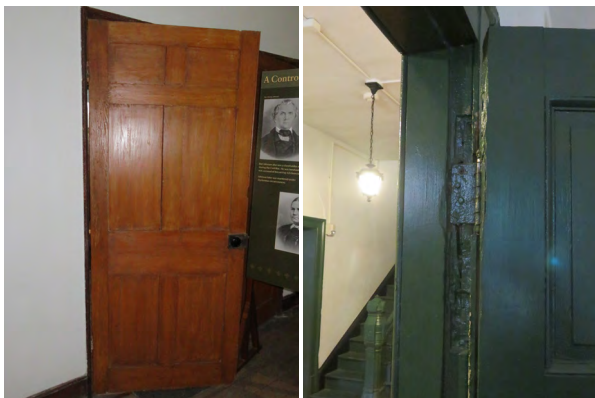
*Left: six-panel door in south exhibit rooms, with box lock. Right: ghosting and damage from many different door installations at office door.*

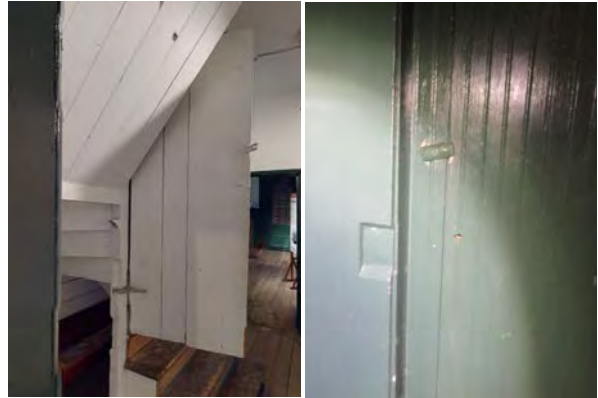
*Left: panel door to attic*

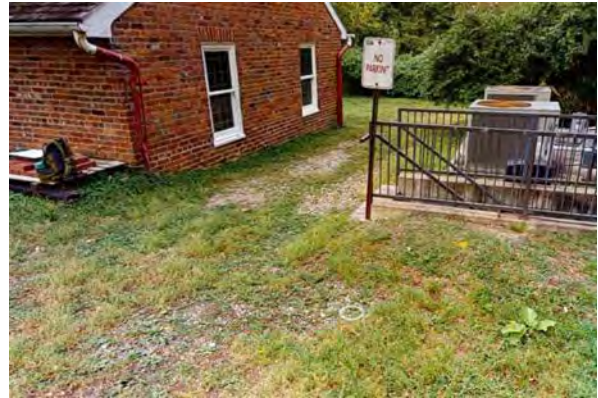
*Area with thin gravel cover. Piping from the downspout in this corner can be seen through gravel in some areas.*

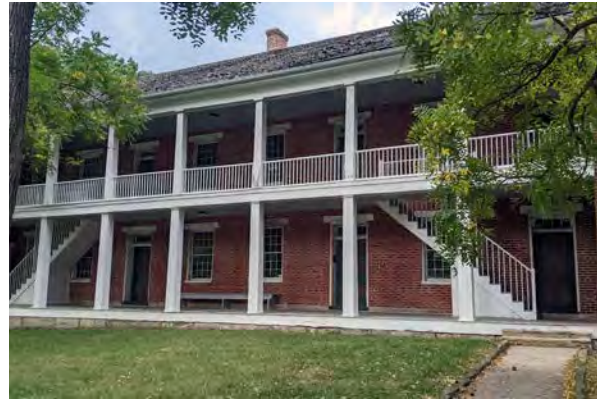
The primary elevation is the south elevation, with a two-story porch spanning most of the facade. The main entrance is denoted by a plaque on the door surround. There are ten doors into the building on this elevation, five on each level. Four of the five doors face south, with the other two facing east. Note that one of the spaces at the second floor west wing is only accessible via the second floor of the porch. This may have been the main dormitory space. Each of the doors are six-panel doors. The south-facing doors have five-lite transoms above the doors, consistent with the East Building. There are two additional doors on the north side of the building that are also six-panel doors, and a vertical panel door at the west elevation leads to a partial cellar. Each of the ten windows are twelve-over-twelve double hung wood windows.

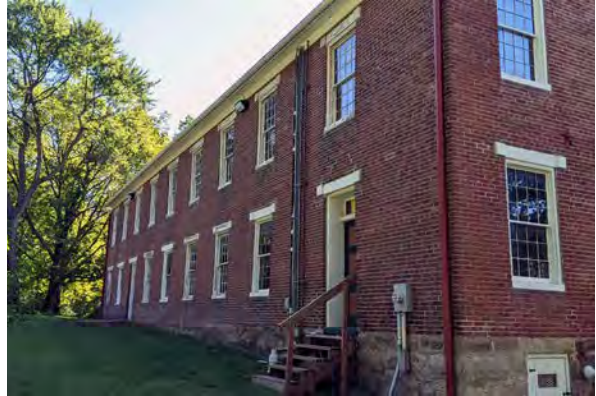
<sup>1</sup> The closet spaces were not accessible during the survey due to exhibit furniture and office furniture stored in this room due to the leaks at the north rooms.

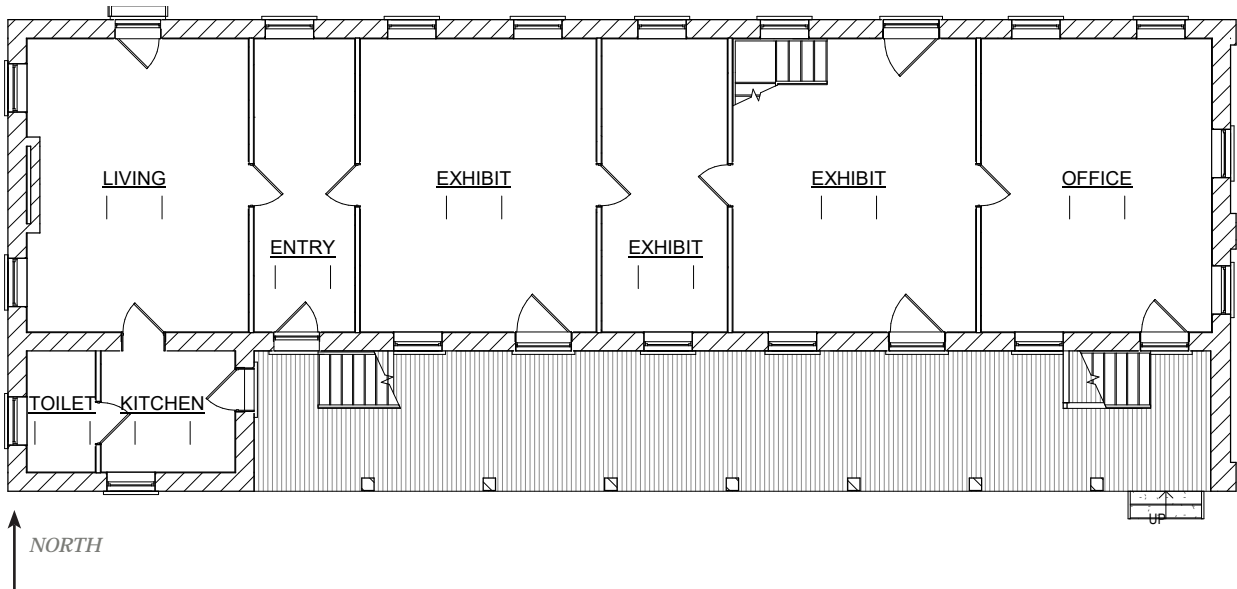
Floor plan, first floor

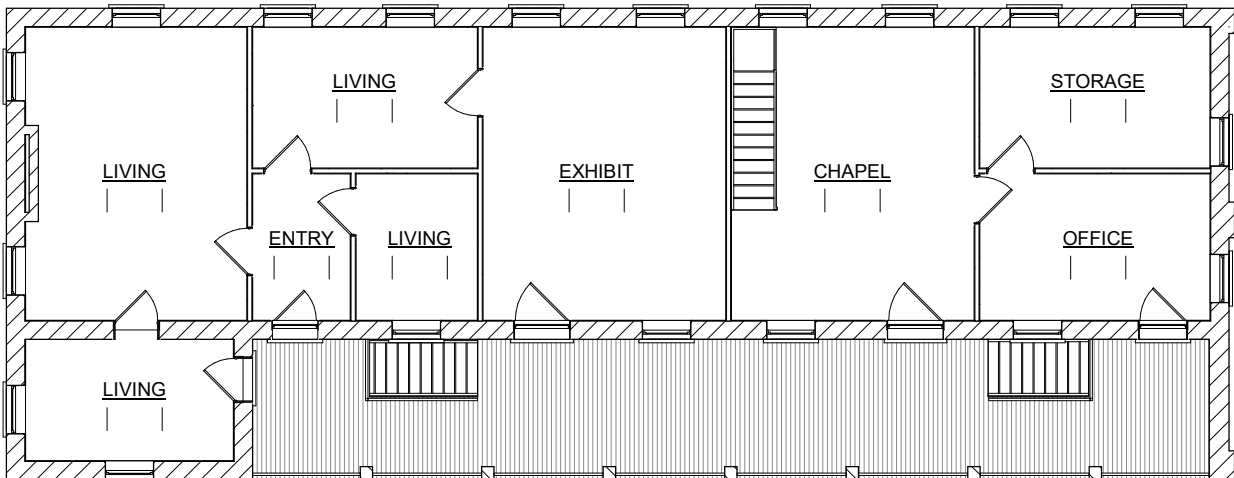
Floor plan, attic floor

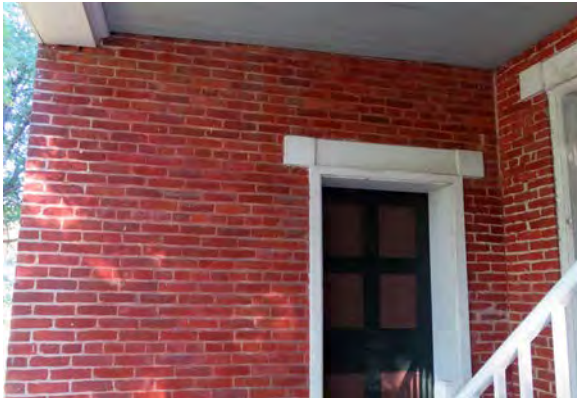
*Masonry. Note the red coating on the brick, which has worn off most of the mortar joints.*

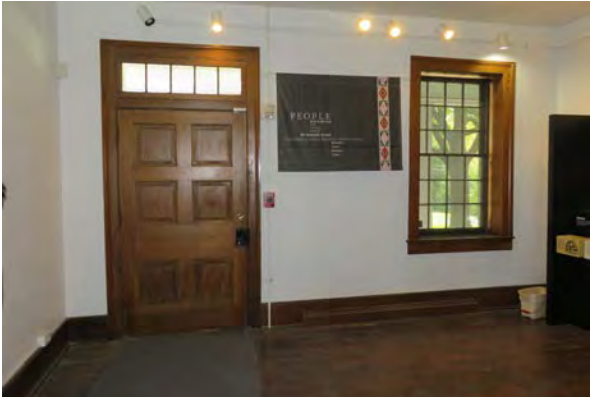
*Door and window surround at the interior.*

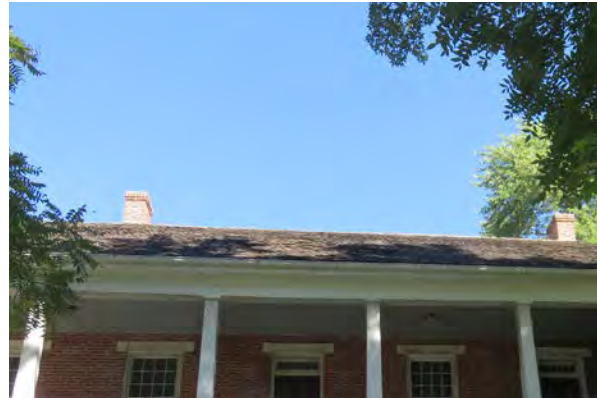
*Roof looking south.*

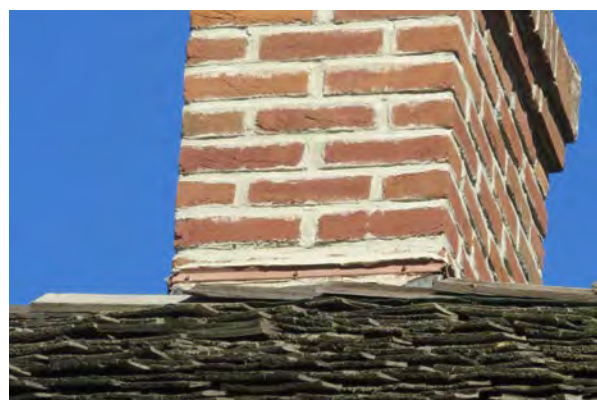
*Deteriorating sealant at west chimney.*

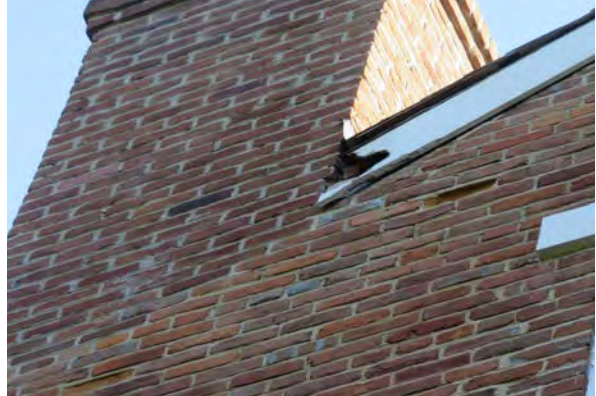
*Hole in fascia panel on west elevation.*

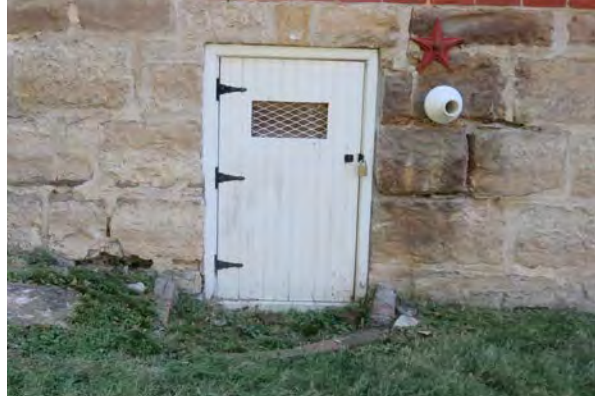
*Open joint around cellar door.*

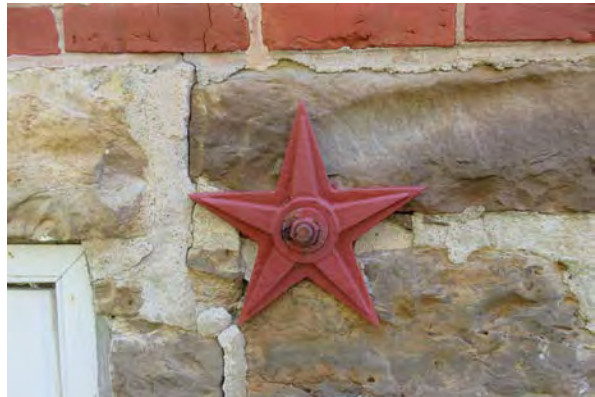
*Paint deterioration and rust at building tie.*

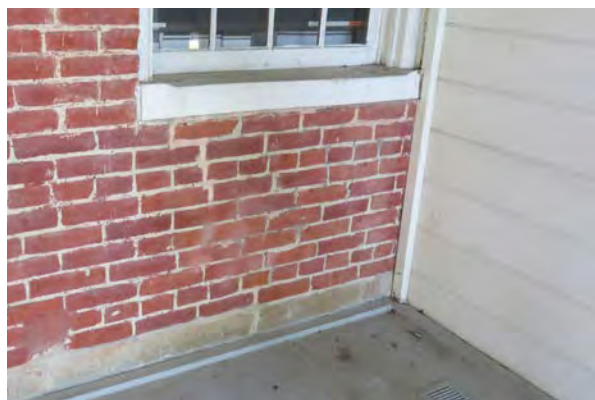
*Open joints below window at the porch.*

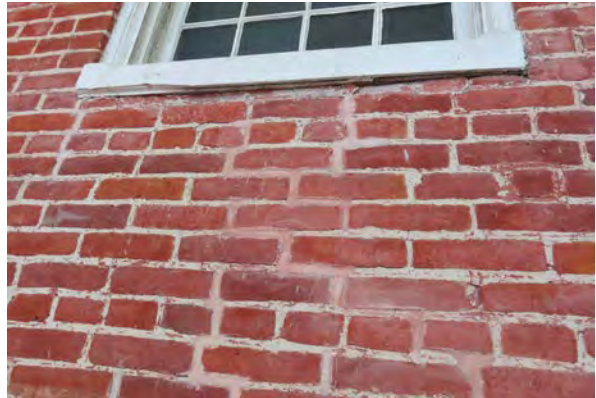
*Area of repointing that does not match the rest of the masonry. Note the traces of red coating on the masonry on the right side.*

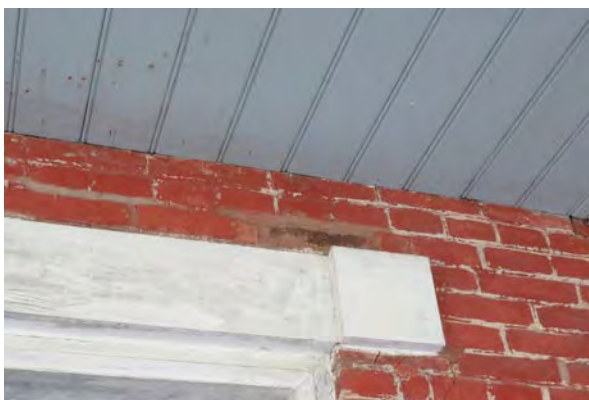
*Previous repair that does not match the adjacent masonry.*
