CONDITIONS ASSESSMENT REPORT

*Architecture  
Planning  
Conservation*

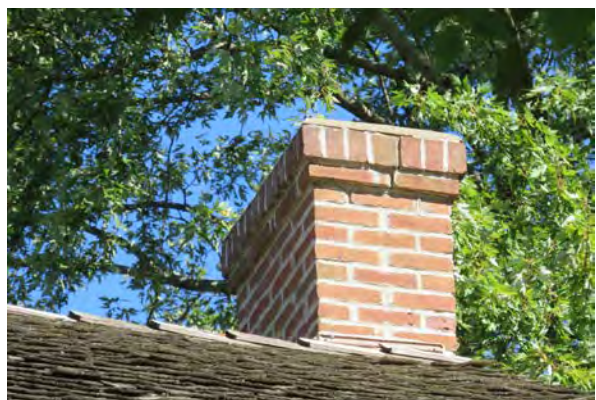
*Cracks at mortar cap and open joint at chimney.*

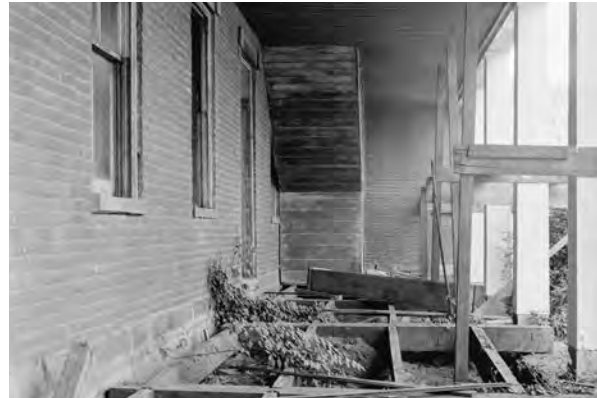
*1940s HABS photo showing missing porch floor at the first floor. Note that the staircases is still intact and may be original.*

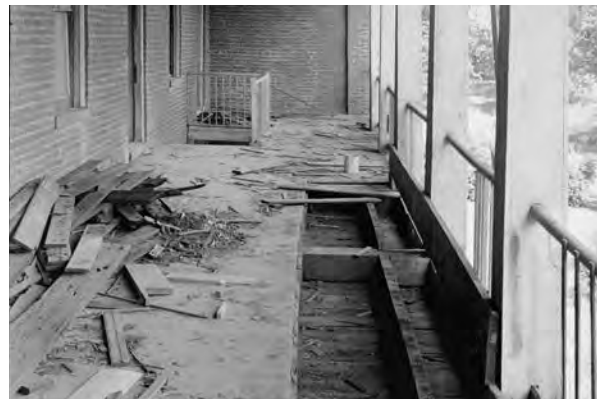
*1940s HABS photo showing missing porch floor at the second floor.*

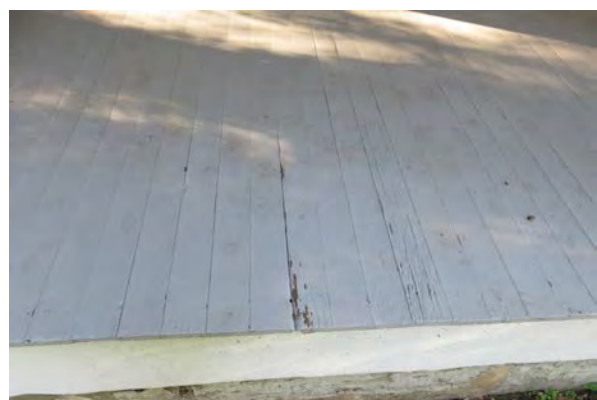
*Damage and deterioration at tongue and groove floor at the first floor.*

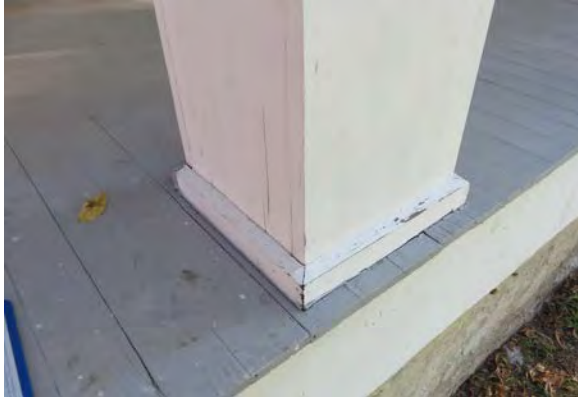
*Paint deterioration, checking, and open seams in wood trim at column bases.*

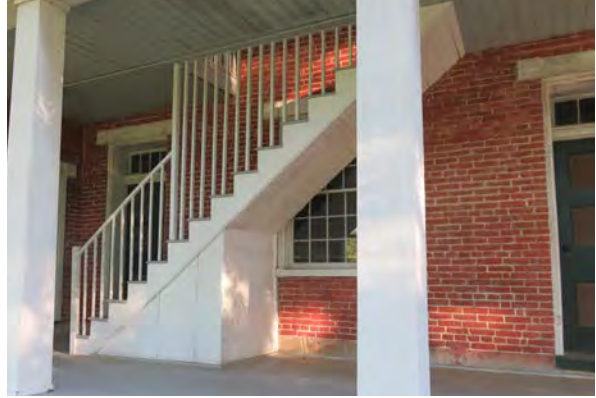
*West staircase to the second floor of the porch. This is one of two potentially historic staircases at the porch.*

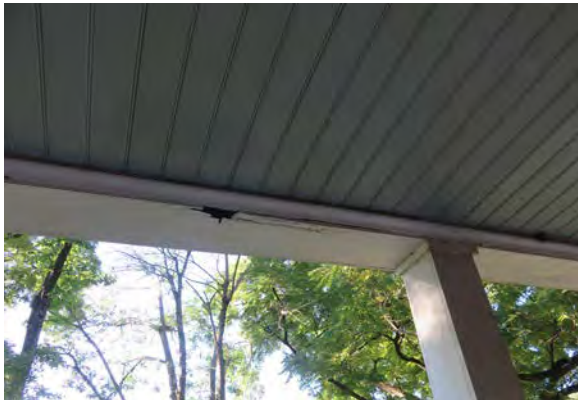
*Wood deterioration at porch soffit.*

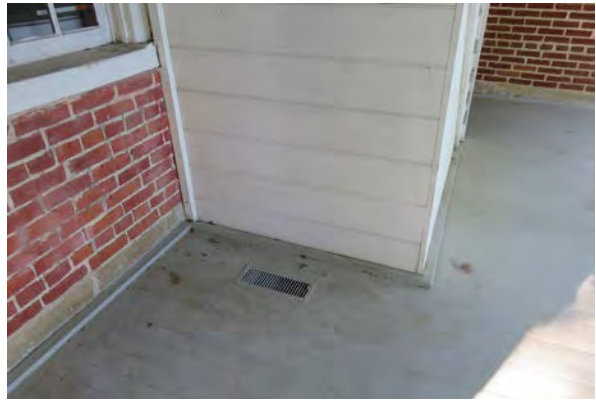
*Vents to the crawl space below were added when the floor was replaced after the 1940s.*

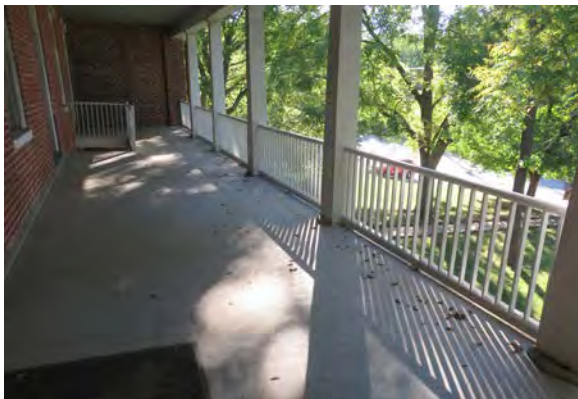
*Second floor porch, looking east.*

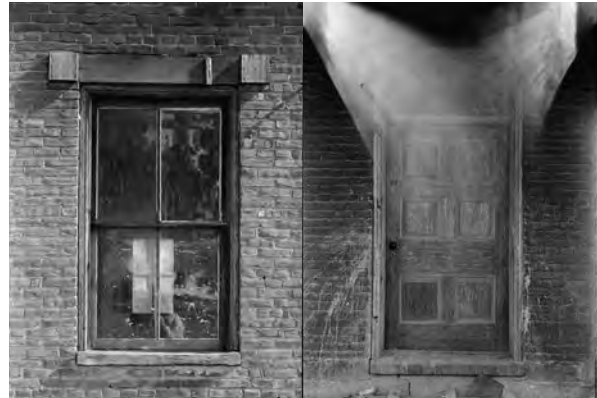
1940a HABS photos showing existing windows and doors.

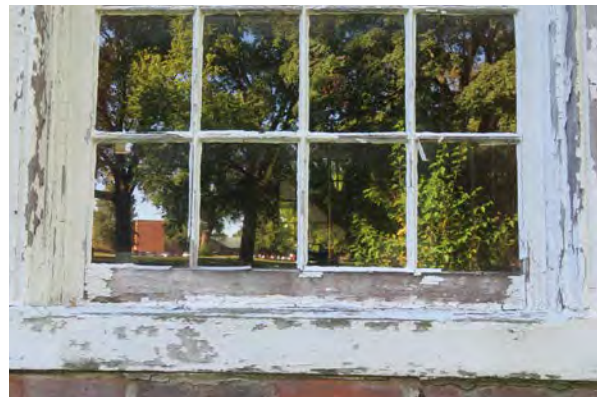
Paint and glazing putty deterioration at a north elevation window.

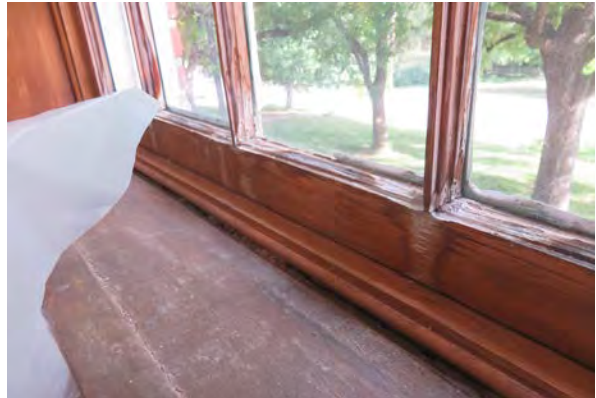
Water damage at new sash, deteriorating finish at window sill.

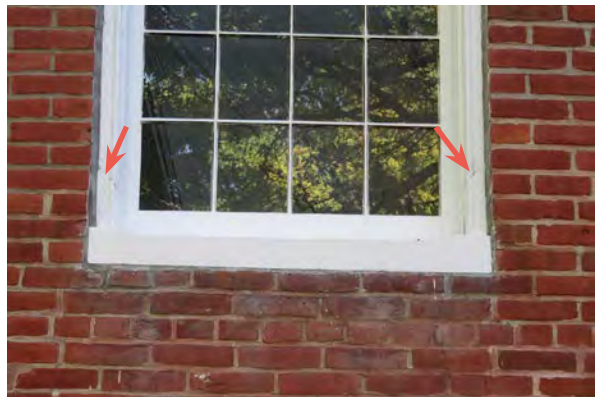
Repaired window where seams from dutchman repairs are visible through the paint. Note the unpainted grey sealant at the edges of the window frame.

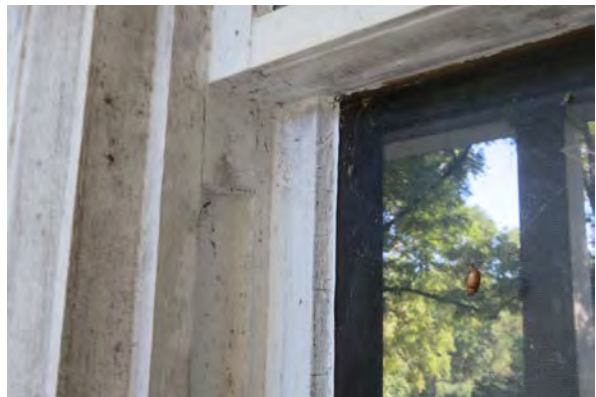
Window at the porch that is painted closed.

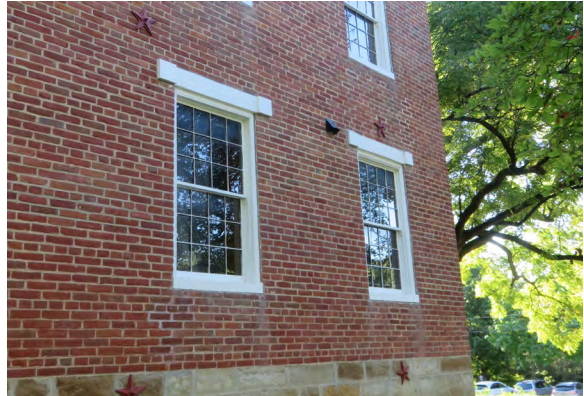
Sashes and surrounds that were repaired in 2016.

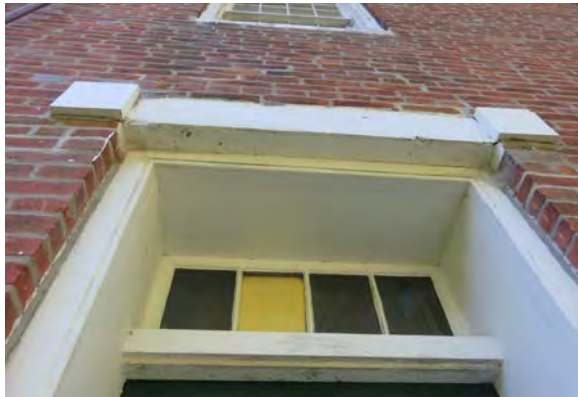
Transom with opaque replacement glass at the northwest door.

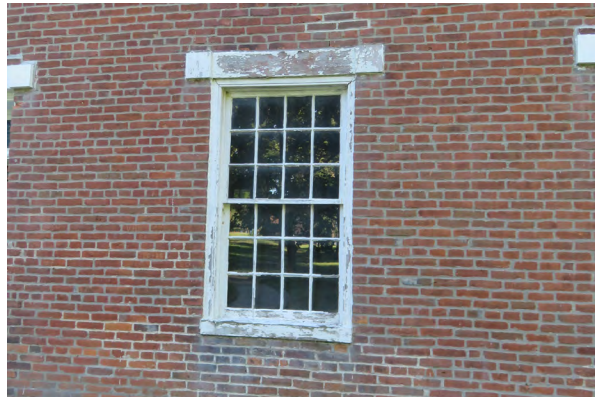
Window with heavy paint and glazing putty deterioration. This window does not appear to have been included in the 2016 scope.

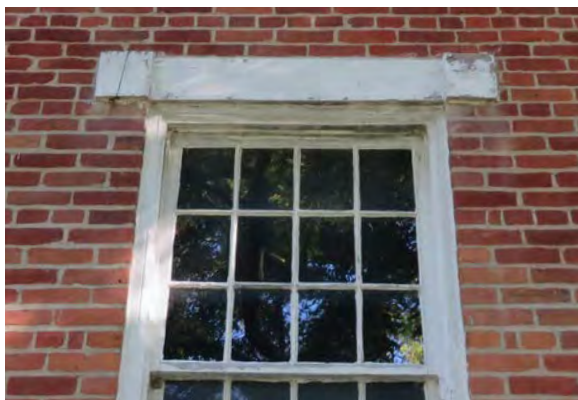
Paint and wood deterioration at flat lintel and raised wood block detail.

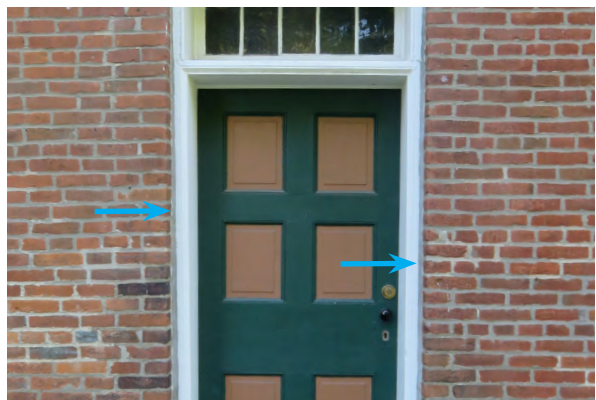
Unpainted grey sealant added at the door surround.

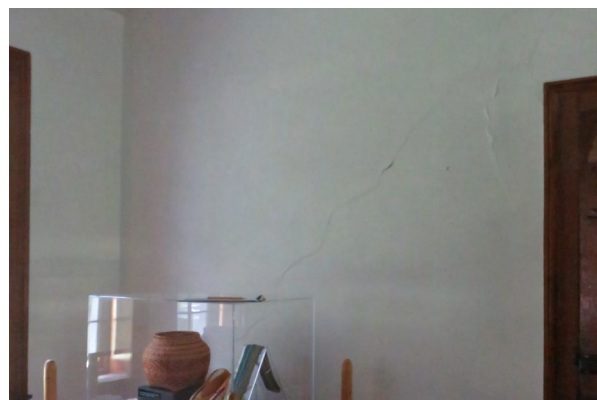
*Plaster cracks in the exhibit room to the west of the main entry room.*

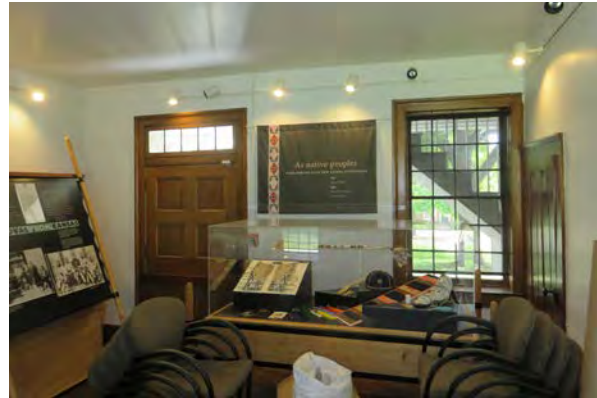
*Exhibit room between small exhibit space and west foyer. This area is used to store materials from the west room which is under repair.*

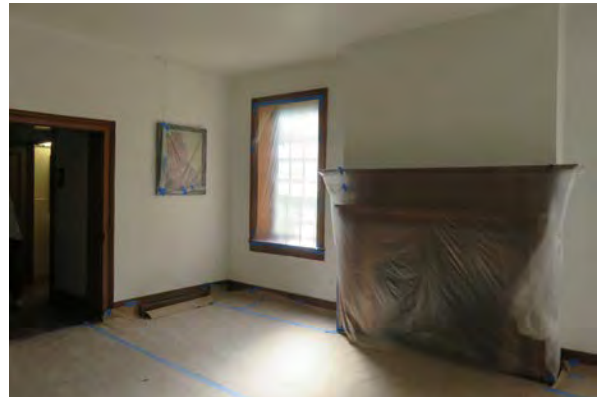
*West room at the first floor. This room is undergoing repairs for a recent leak.*

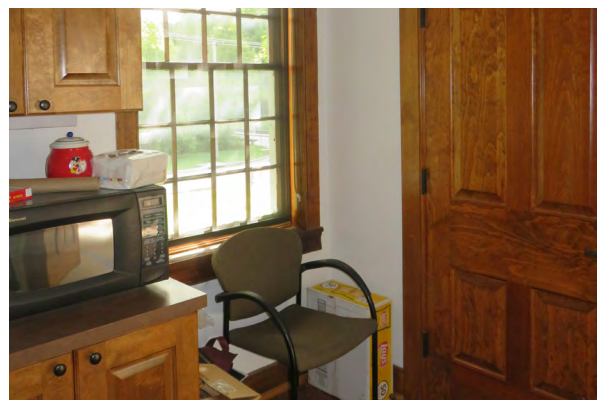
*Kitchen and door to the modern restroom.*

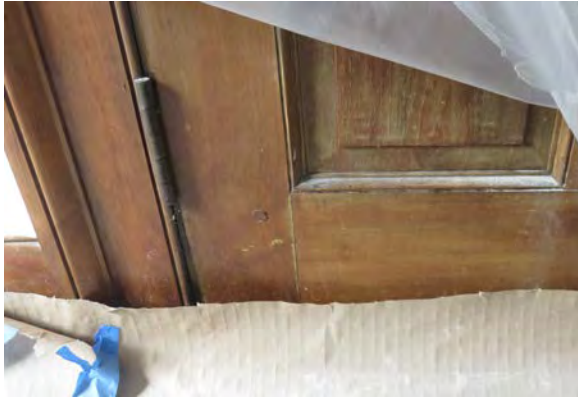
*Water damaged finish at door to the north elevation in the first floor west room.*

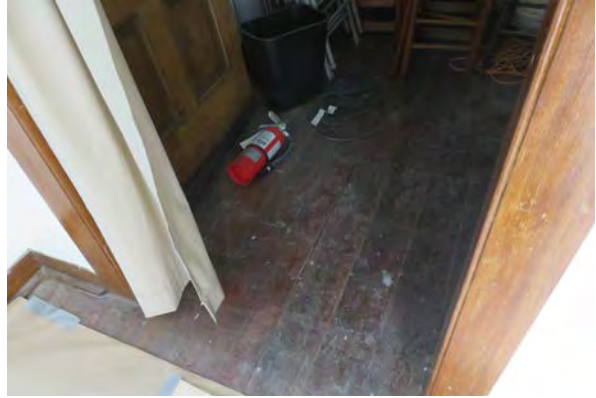
*Typical wood floor at the second floor.*

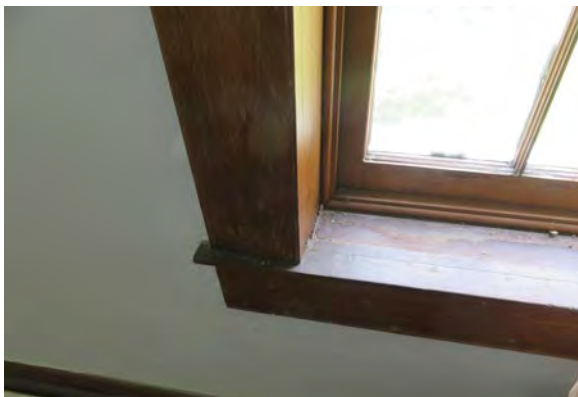
*Water damaged finish at window sill from previous water infiltration issue.*

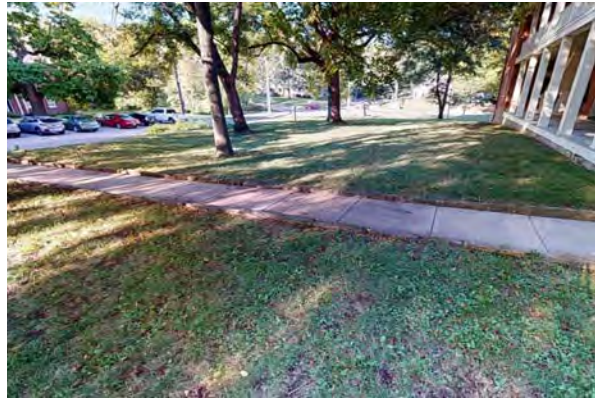
*Path at primary south elevation.*

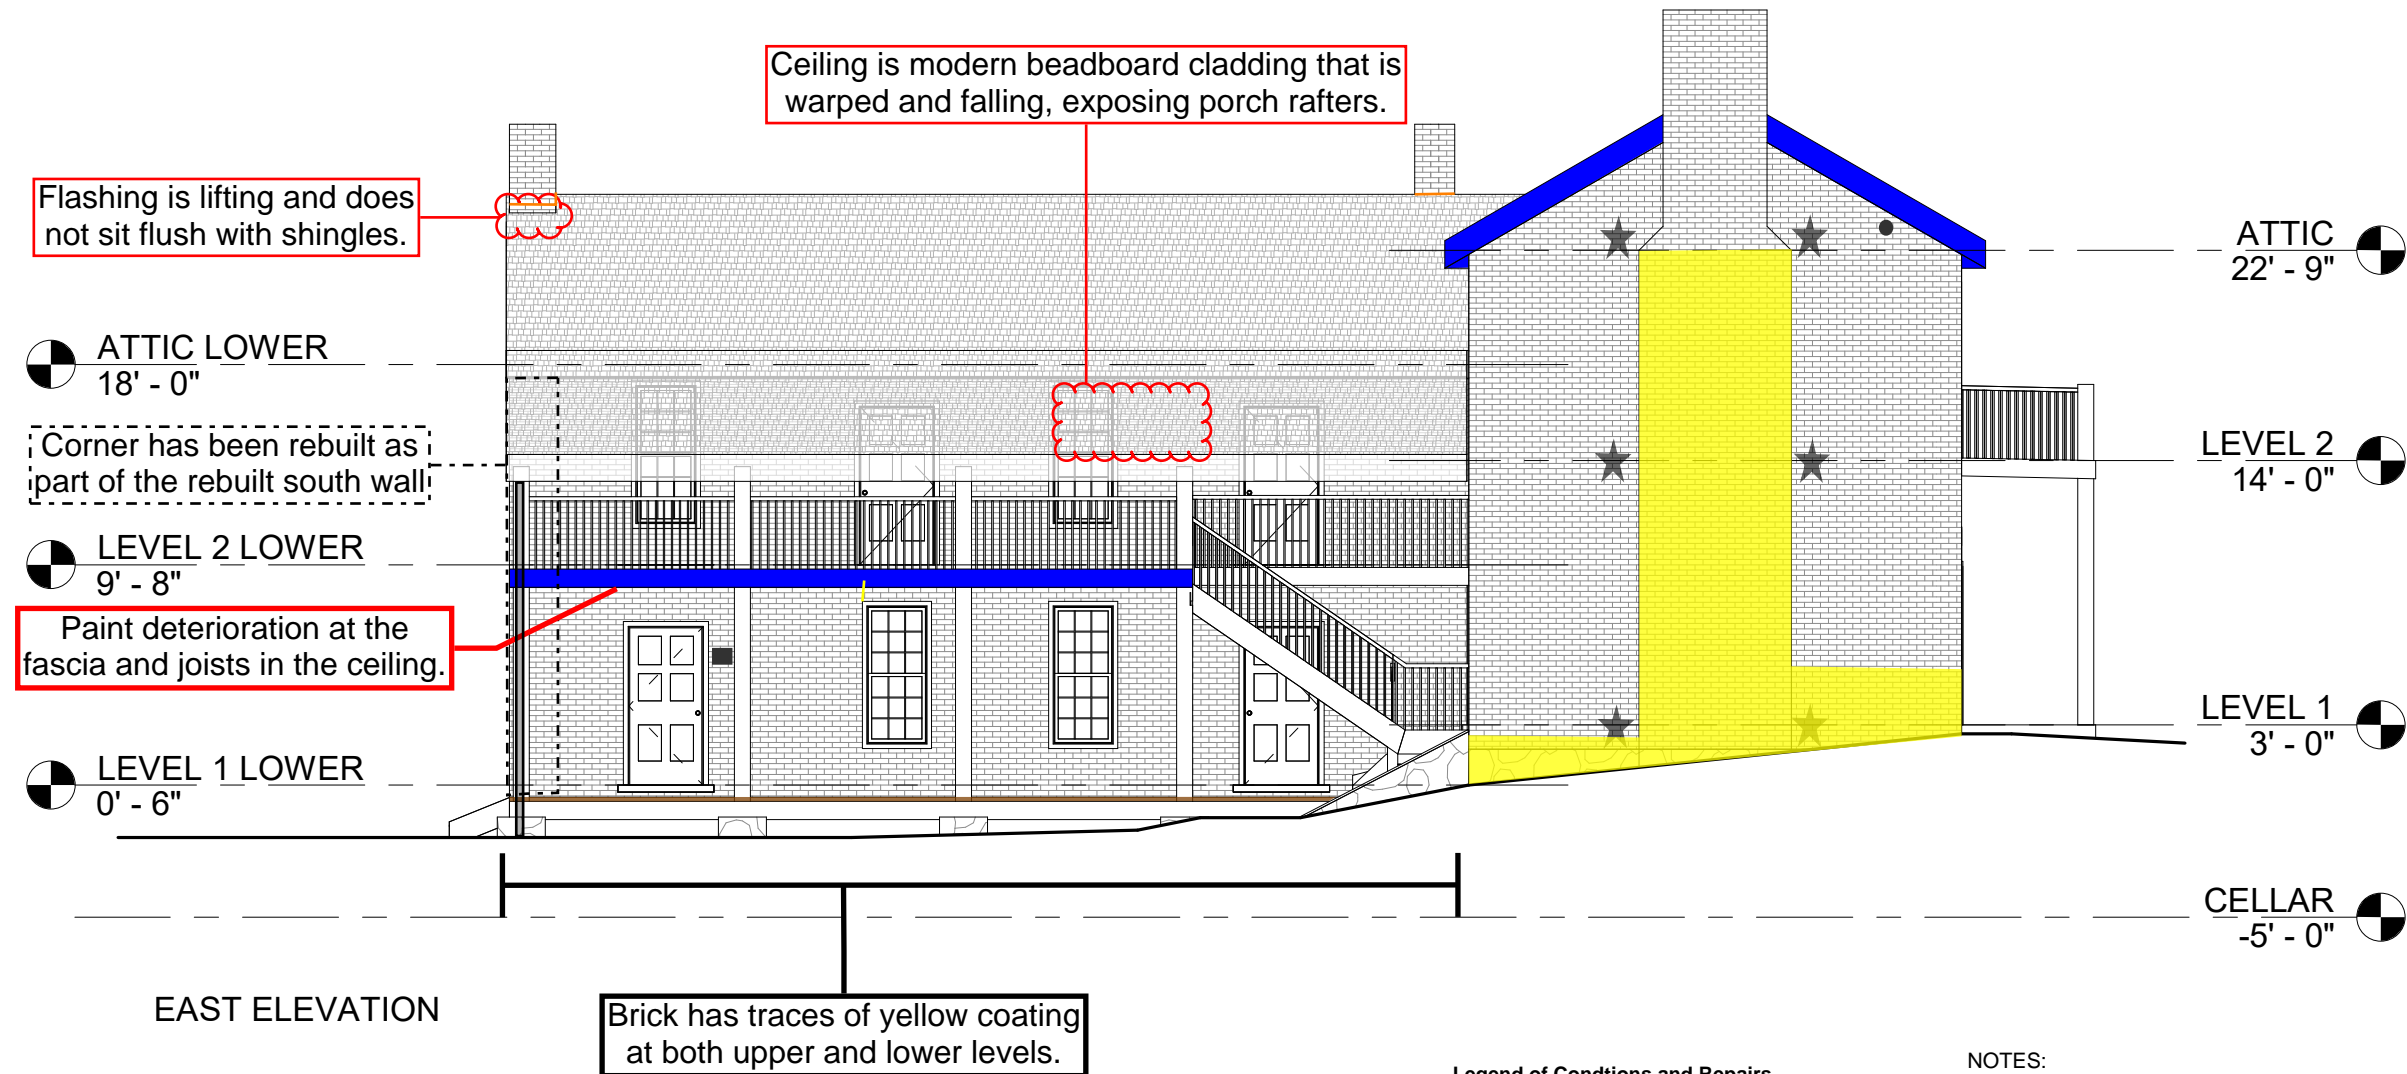
## Existing Condition Survey Drawings

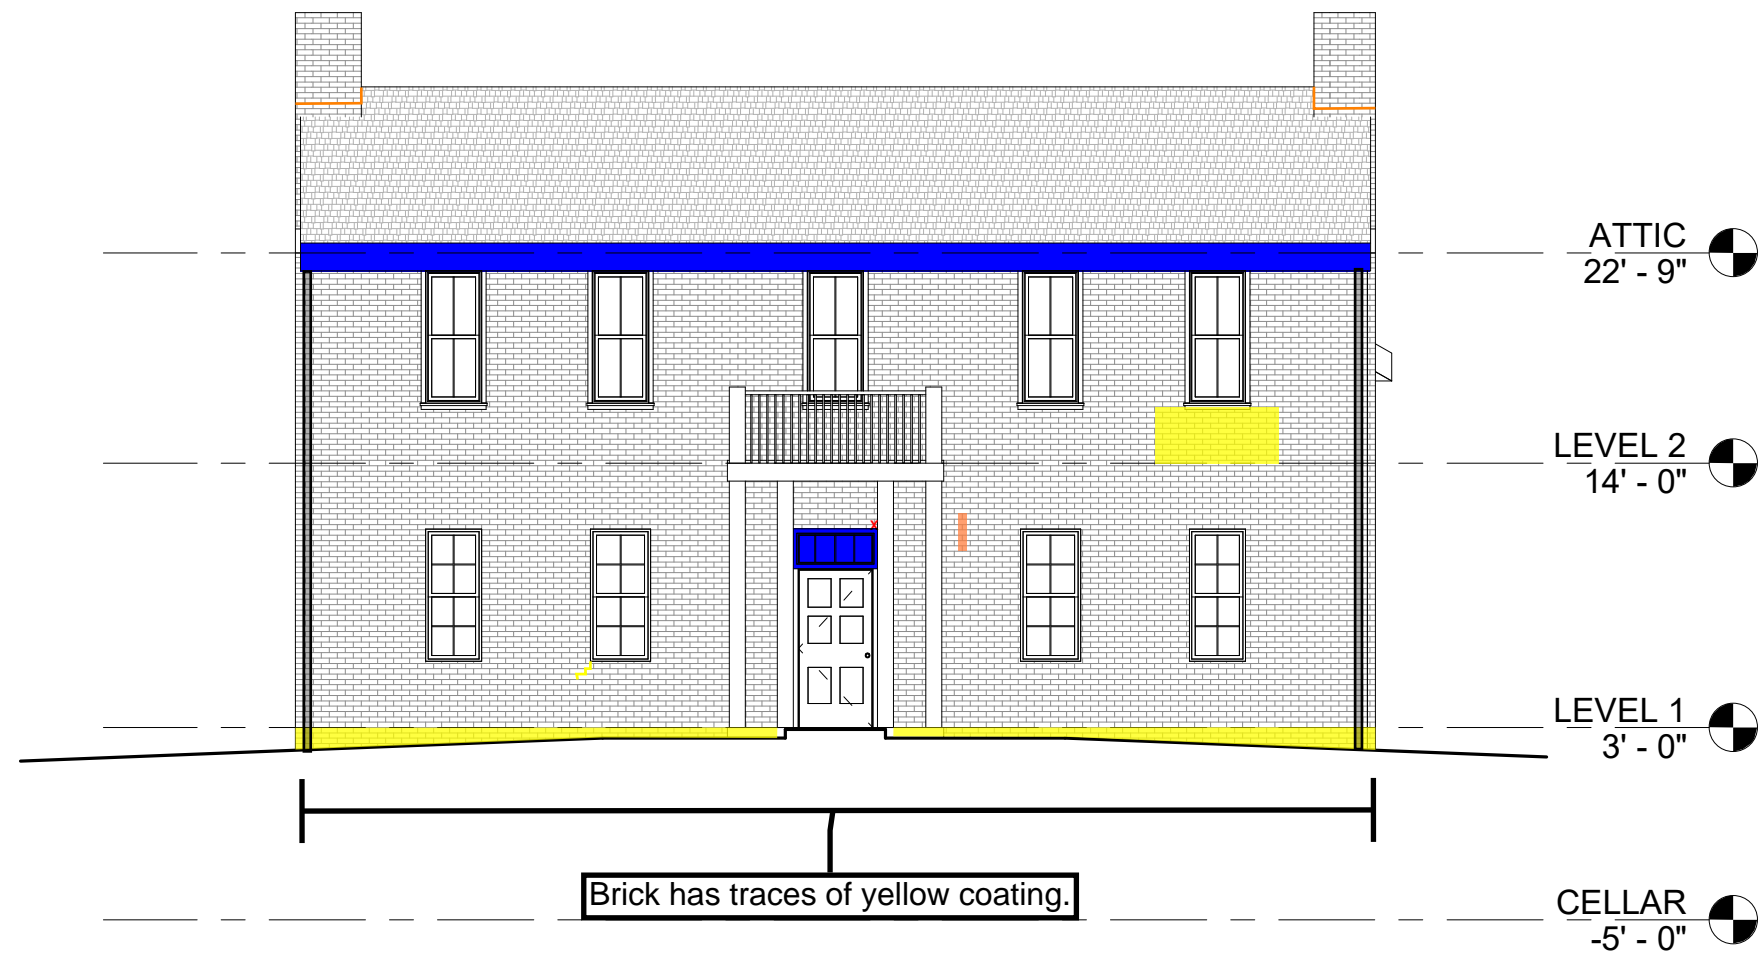
- Paint on soffit is very deteriorated.
- Foundation is rough-hewn rectangular limestone.
- Open joints in the limestone foundation vary and can be very large in size.
- There are multiple areas of brick infill that vary in size from single bricks to larger sections of walls and corners. The brick is a fair match for the existing brick, that is slightly darker in color and with more color variation than the original.
- Wood and paint deterioration at edges of floorboards at the first level of the porch.
- General paint deterioration and wear on porch floor.
- Second floor porch plate is rough hewn timber. The rafters are concealed by modern bead board cladding.
- Mortar caps on chimneys are in poor condition and should be replaced during repointing.
- Porch roof has isolated areas of lifting shingles

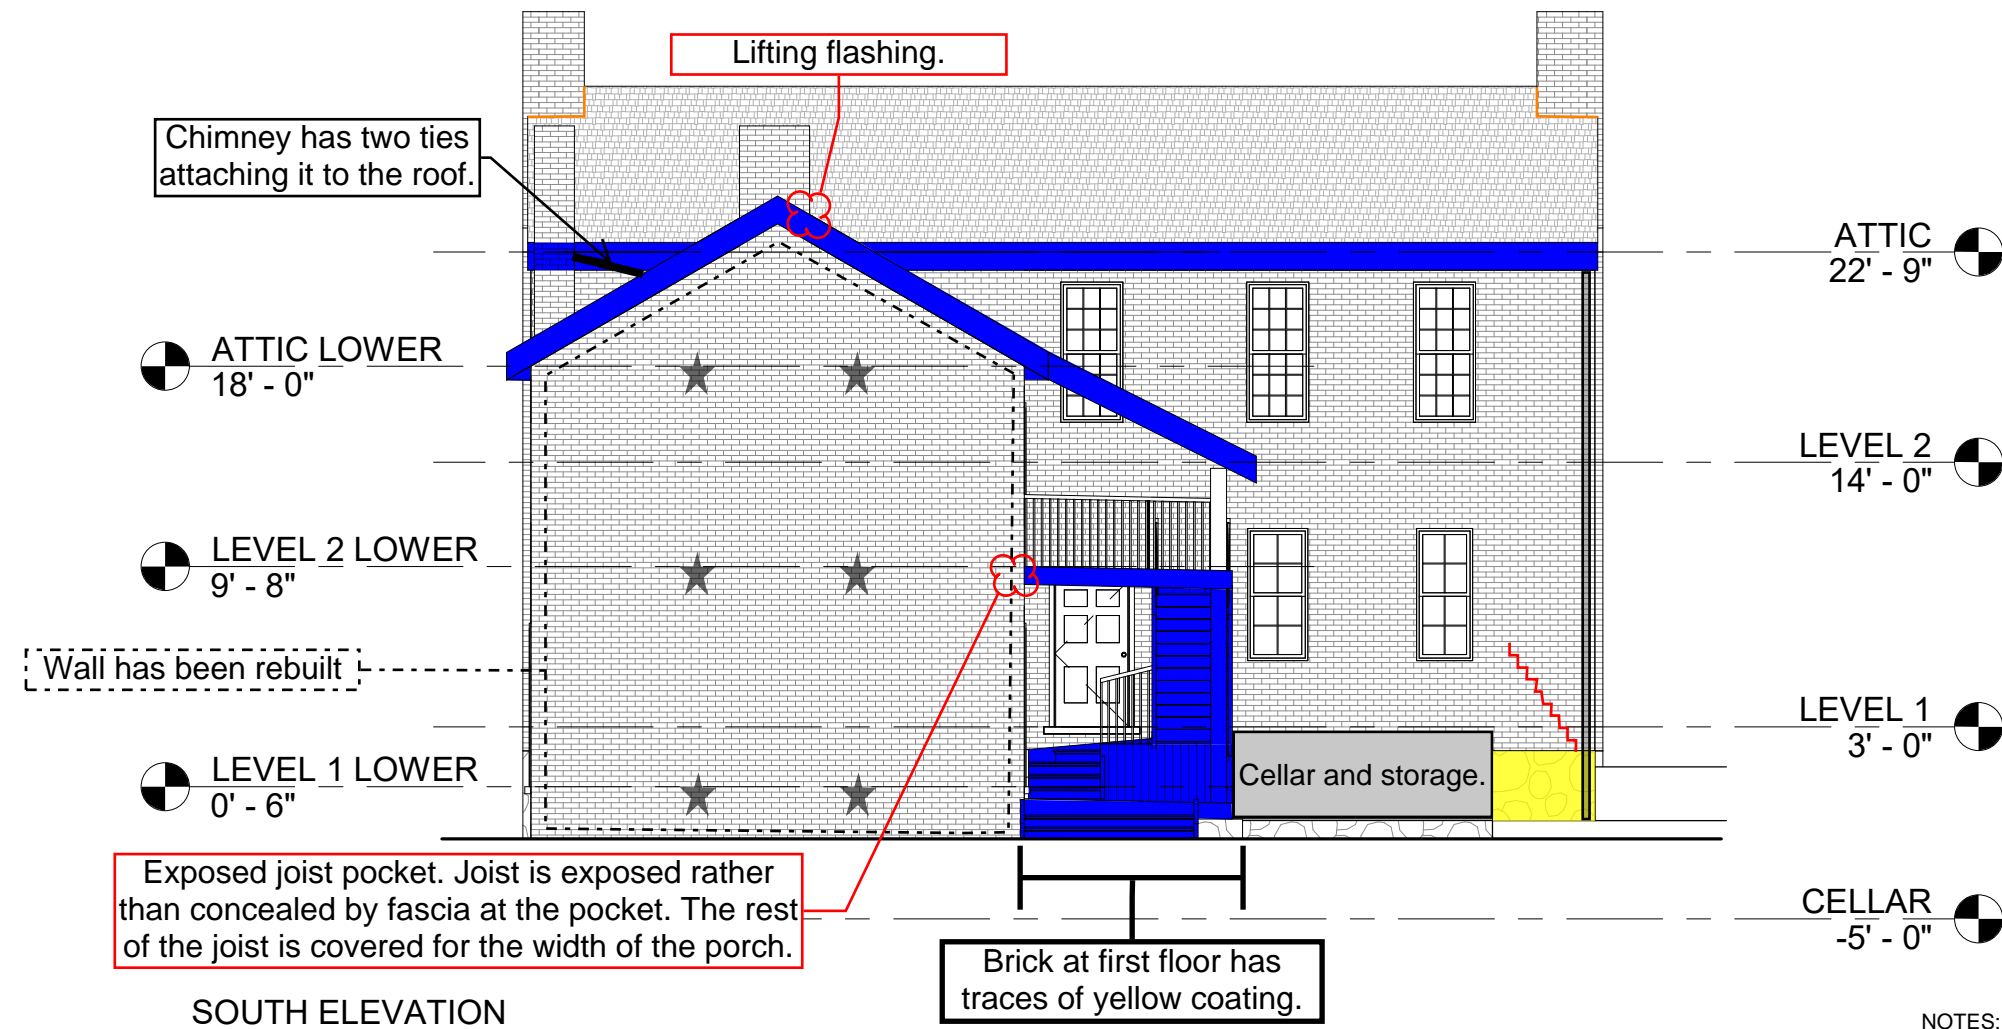
NOTES:  
 --There are multiple areas of brick infill that vary in size from single bricks to larger sections of walls and corners. The brick is a fair match for the existing brick, that is slightly darker in color and with more color variation than the original.  
 --Wood and paint deterioration at porch, especially at floor and column bases.  
 --The brick bond on this portion of the building is not consistent with the rear addition or with the other buildings at the site.  
 --Sealant around windows and doors appears to be in serviceable condition, date of previous repair or replacement is unknown.  
 --The roof shingles shows early signs of curling but is overall in good to fair condition. Sealant at chimney flashing shows signs of cracking and should be replaced.  
 --Mortar caps on chimneys are in poor condition and should be replaced during repointing.

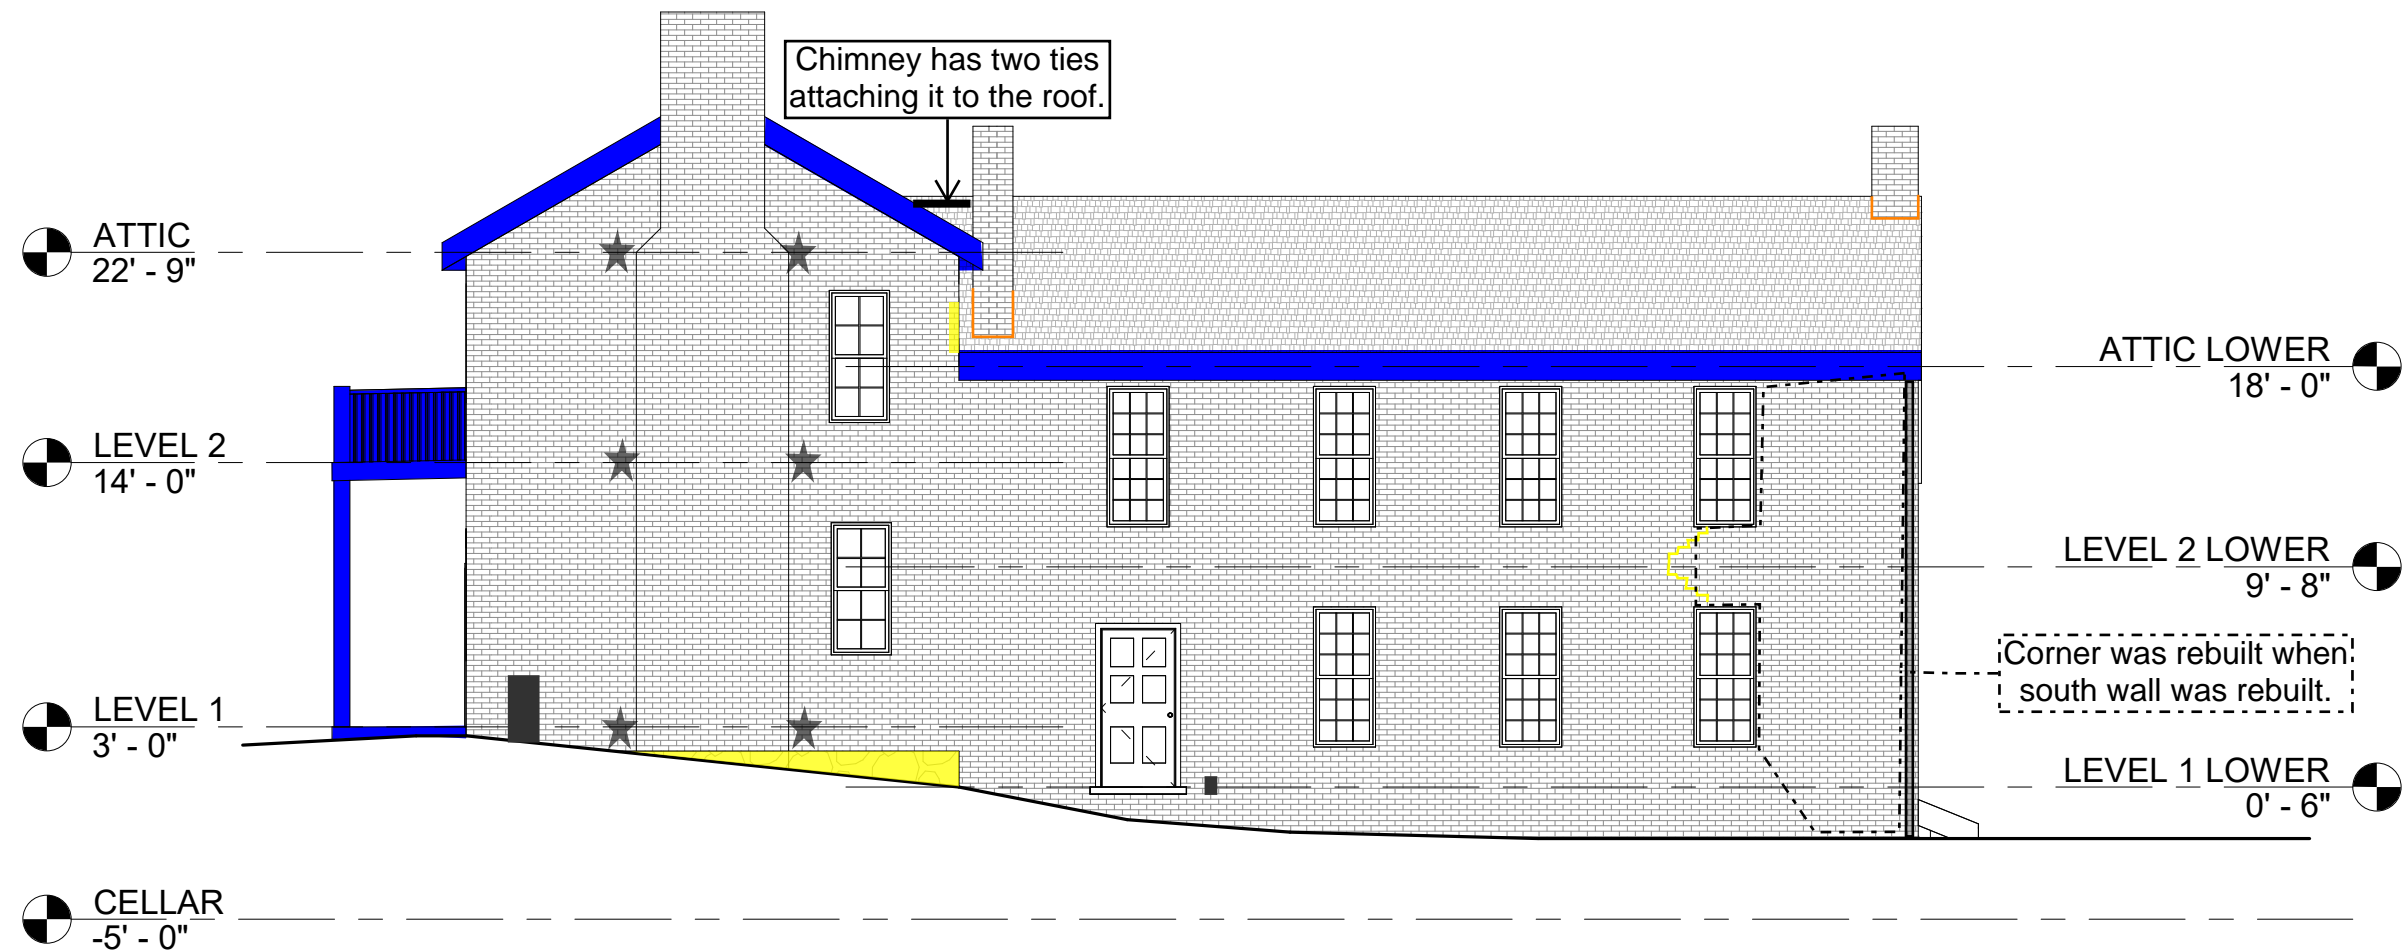
- Paint on soffit is very deteriorated.
- There are multiple areas of brick infill that vary in size from single bricks to larger sections of walls and corners. The brick is a fair match for the existing brick, that is slightly darker in color and with more color variation than the original.
- Sealant around windows and doors appears to be in serviceable condition, date of previous repair or replacement is unknown.
- The roof shingles shows early signs of curling but is overall in good to fair condition. Sealant at chimney flashing shows signs of cracking and should be replaced.
- Wood and paint deterioration at edges of floorboards at the first level of the porch.
- General paint deterioration and wear on porch floor.
- Open joints in the limestone foundation vary and can be very large in size.
- Mortar caps on chimneys are in poor condition and should be replaced during repointing.

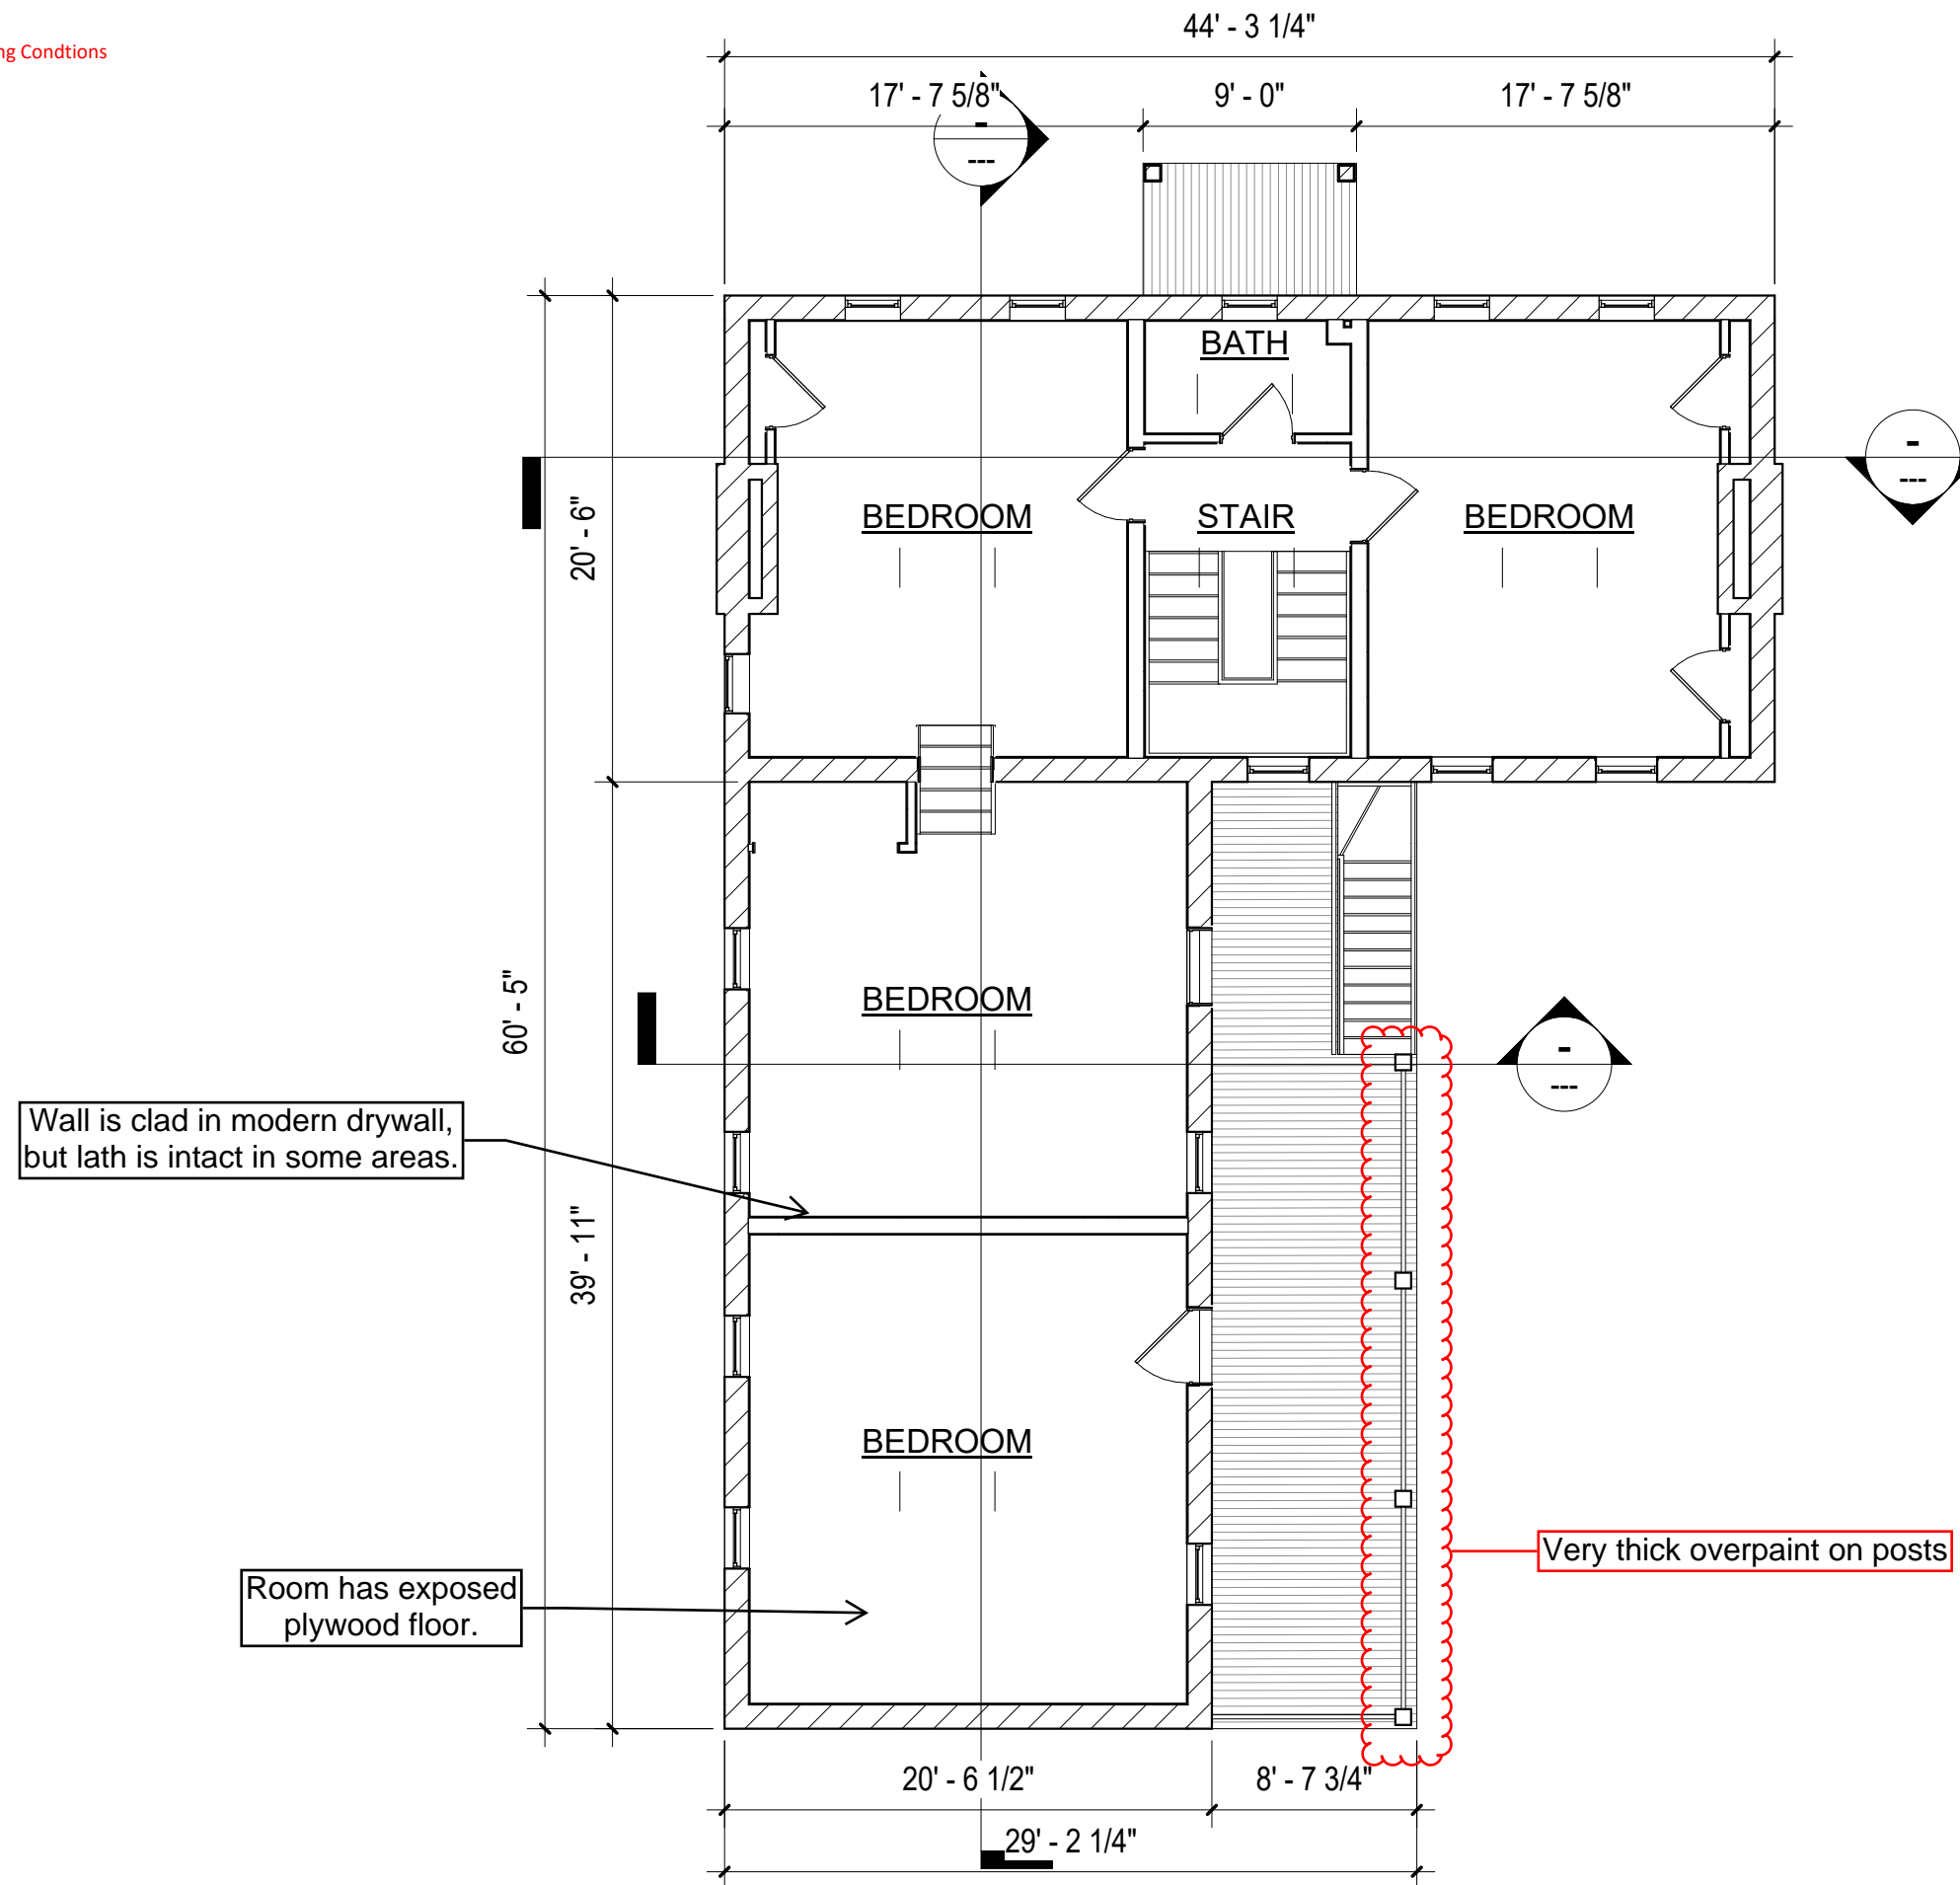
- Paint on soffit is very deteriorated.
- There are multiple areas of brick infill that vary in size from single bricks to larger sections of walls and corners. The brick is a fair match for the existing brick, that is slightly darker in color and with more color variation than the original.
- Sealant around windows and doors appears to be in serviceable condition, date of previous repair or replacement is unknown.
- The roof shingles shows early signs of curling but is overall in good to fair condition. Sealant at chimney flashing shows signs of cracking and should be replaced.
- Open joints in the limestone foundation vary and can be very large in size.
- Mortar caps on chimneys are in poor condition and should be replaced during repointing.

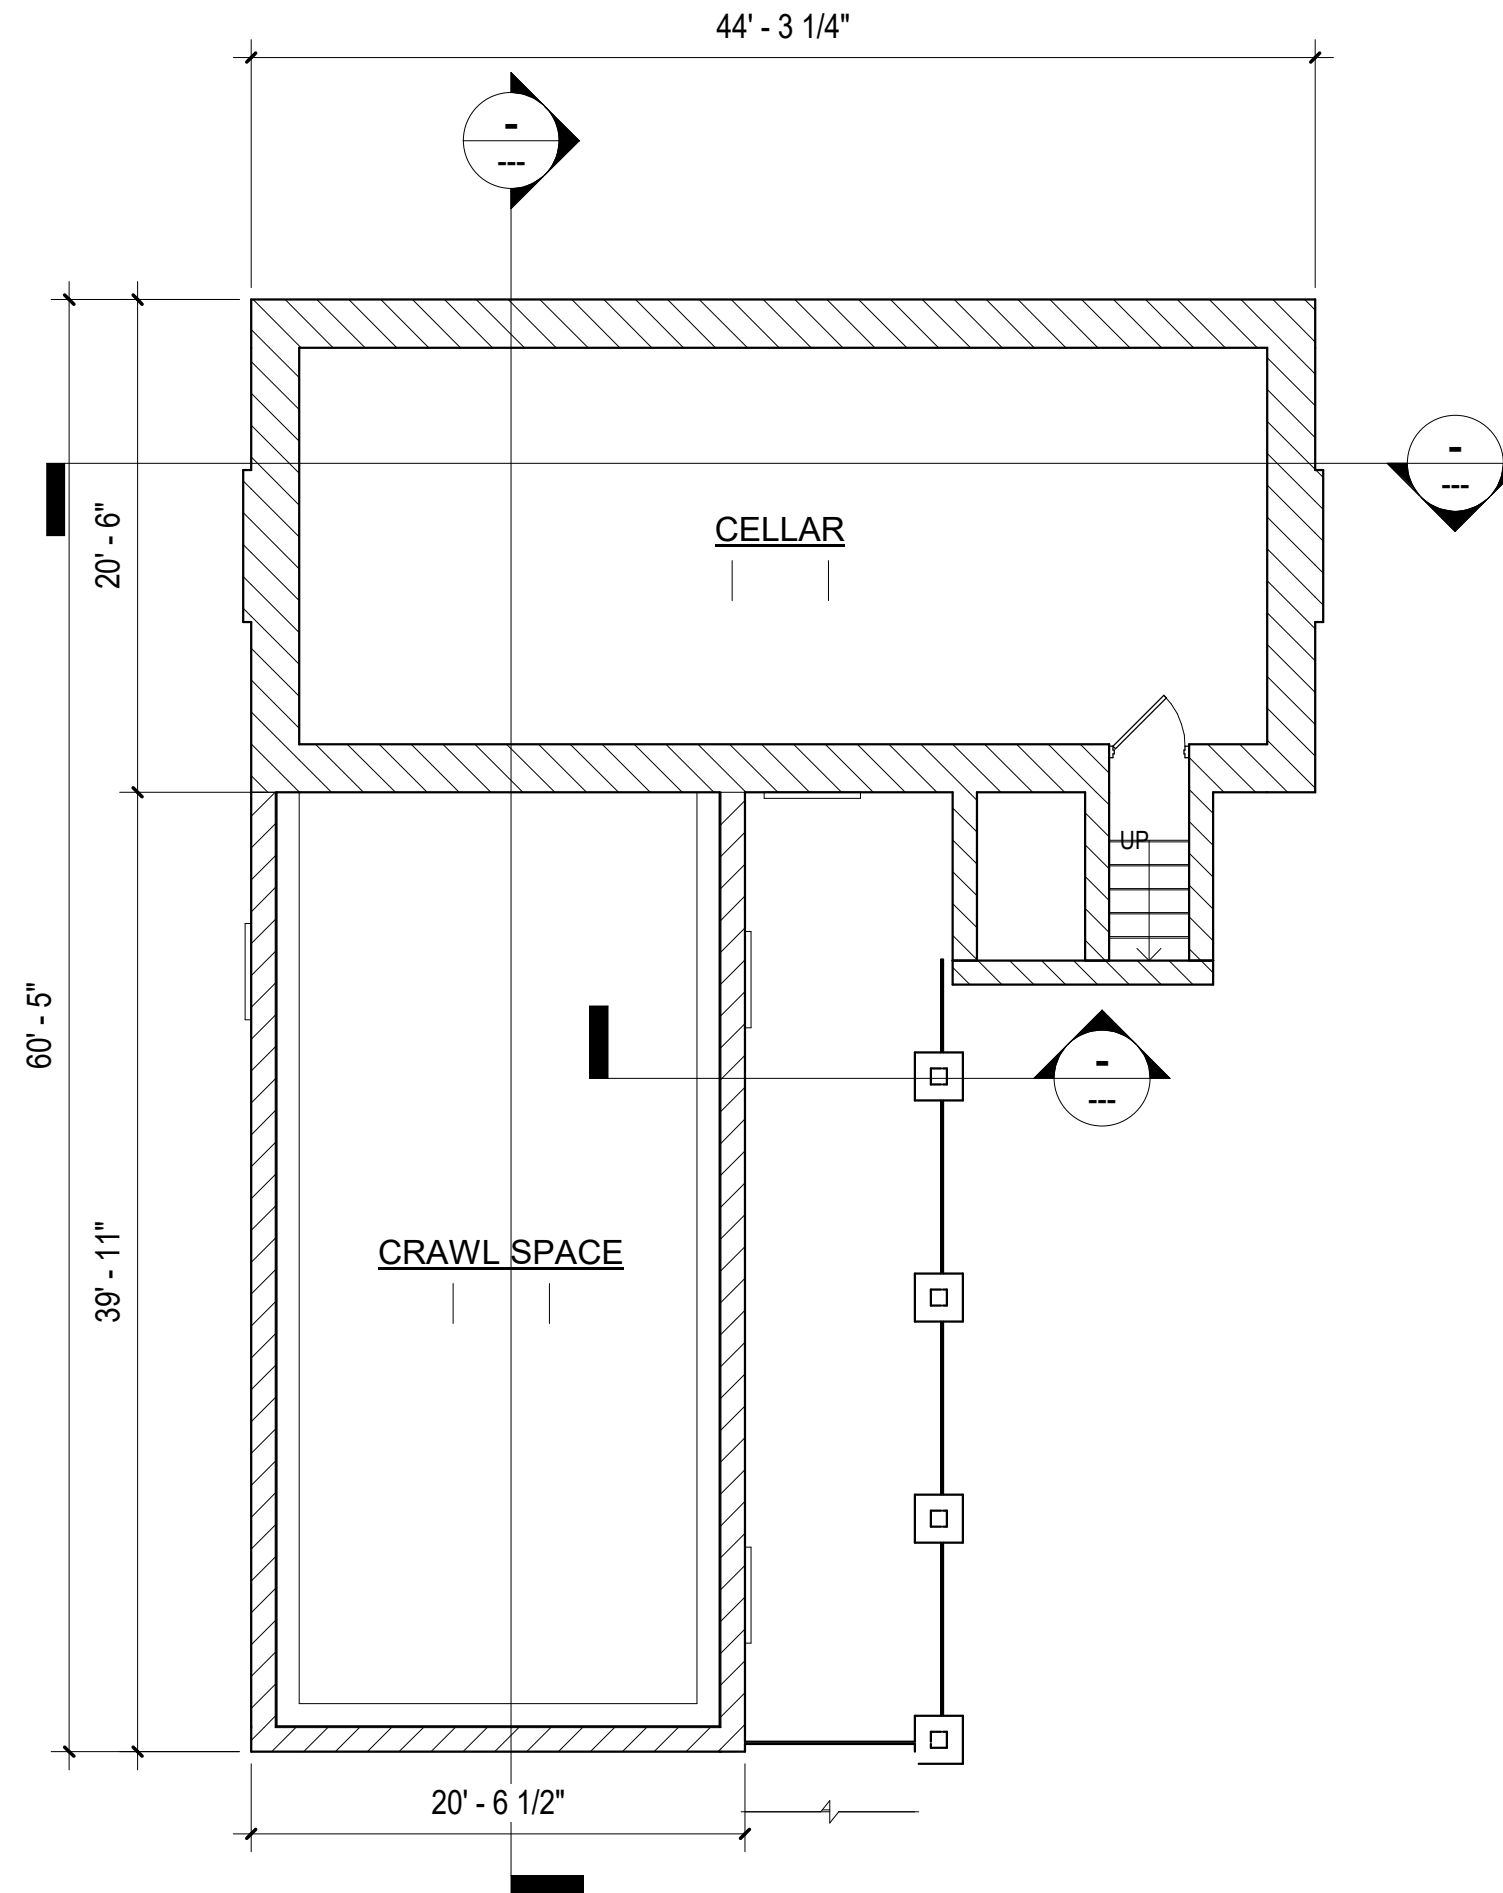
NOTES:  
 --Floors are painted. Finish is heavily worn.  
 --There are patches on the floors where holes or penetrations are covered with sheet metal nailed in place.  
 --Very few intact finishes. Wallpaper was removed and plaster stripped to lath in some places, likely from the remediation of the water leak in 2013.  
 --There are multiple repairs to the plaster around the windows and mantles in all rooms.  
 --Sections of second floor railing were replaced at the south end due to damage caused by "teenagers".
