CONDITIONS ASSESSMENT REPORT

*Architecture  
Planning  
Conservation*

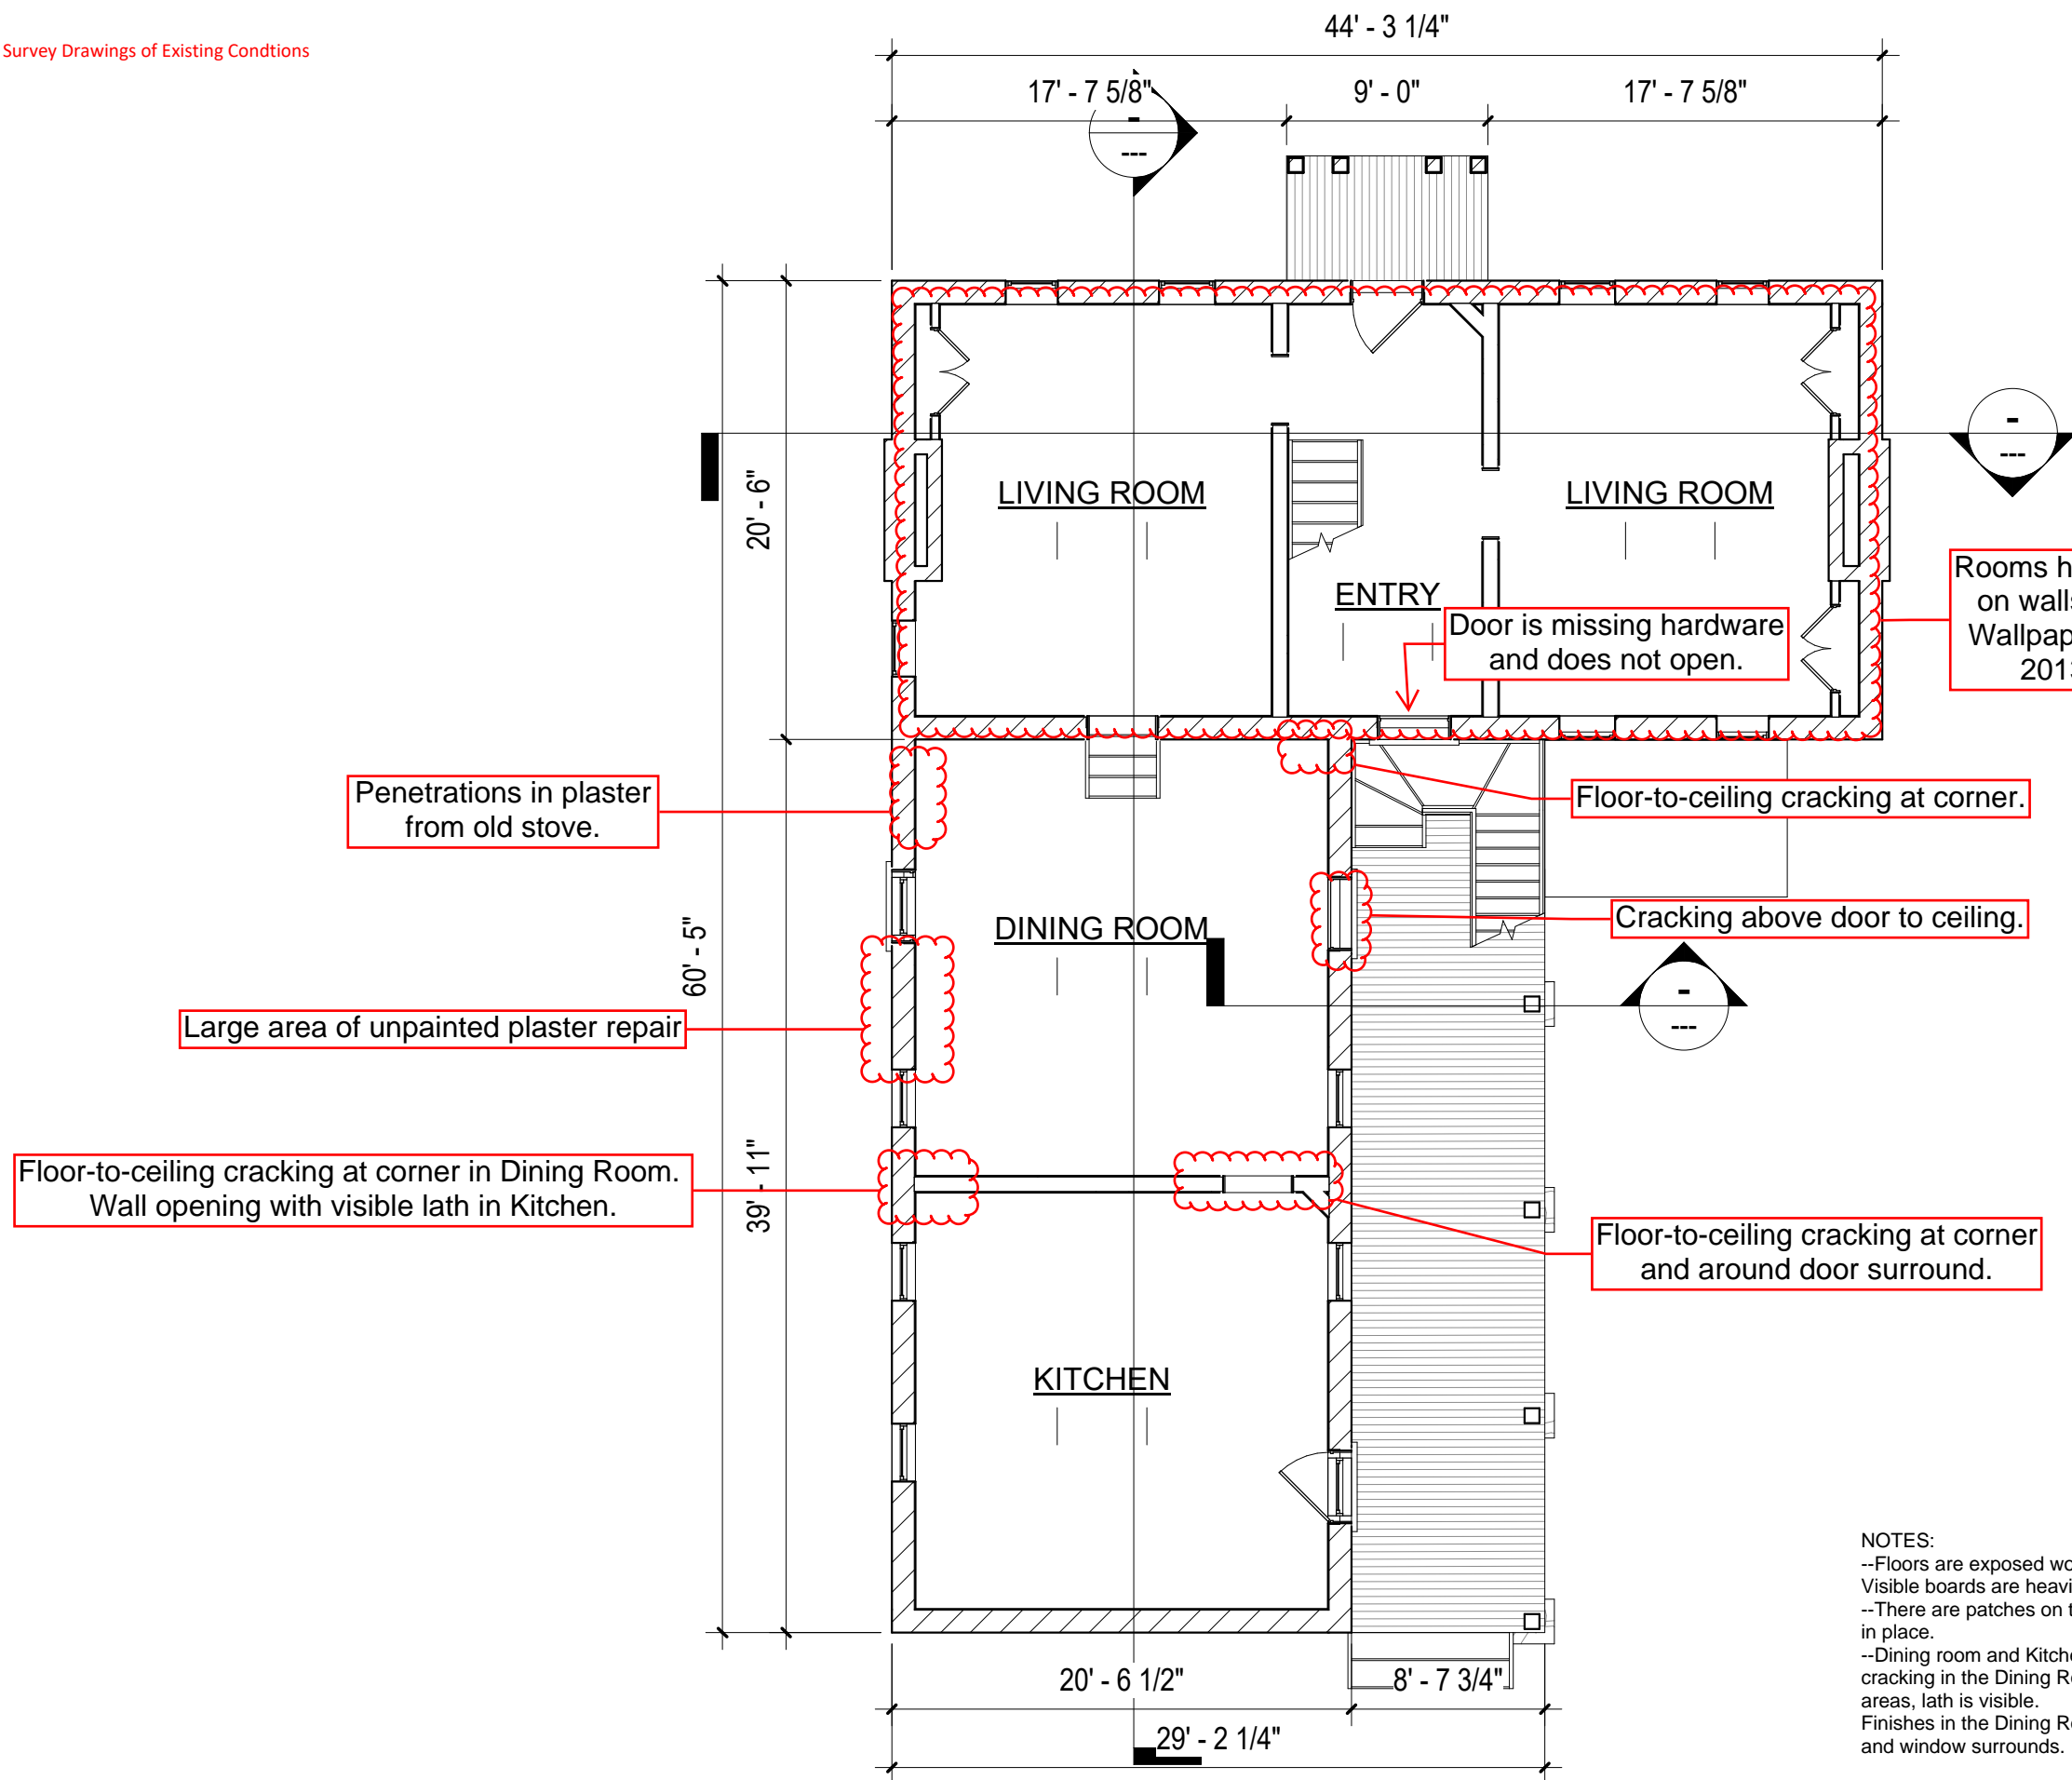
Rooms have no intact plaster or other finishes on walls or ceilings, except inside built-ins. Wallpaper and plaster were removed during 2013 remediation due to water leak.

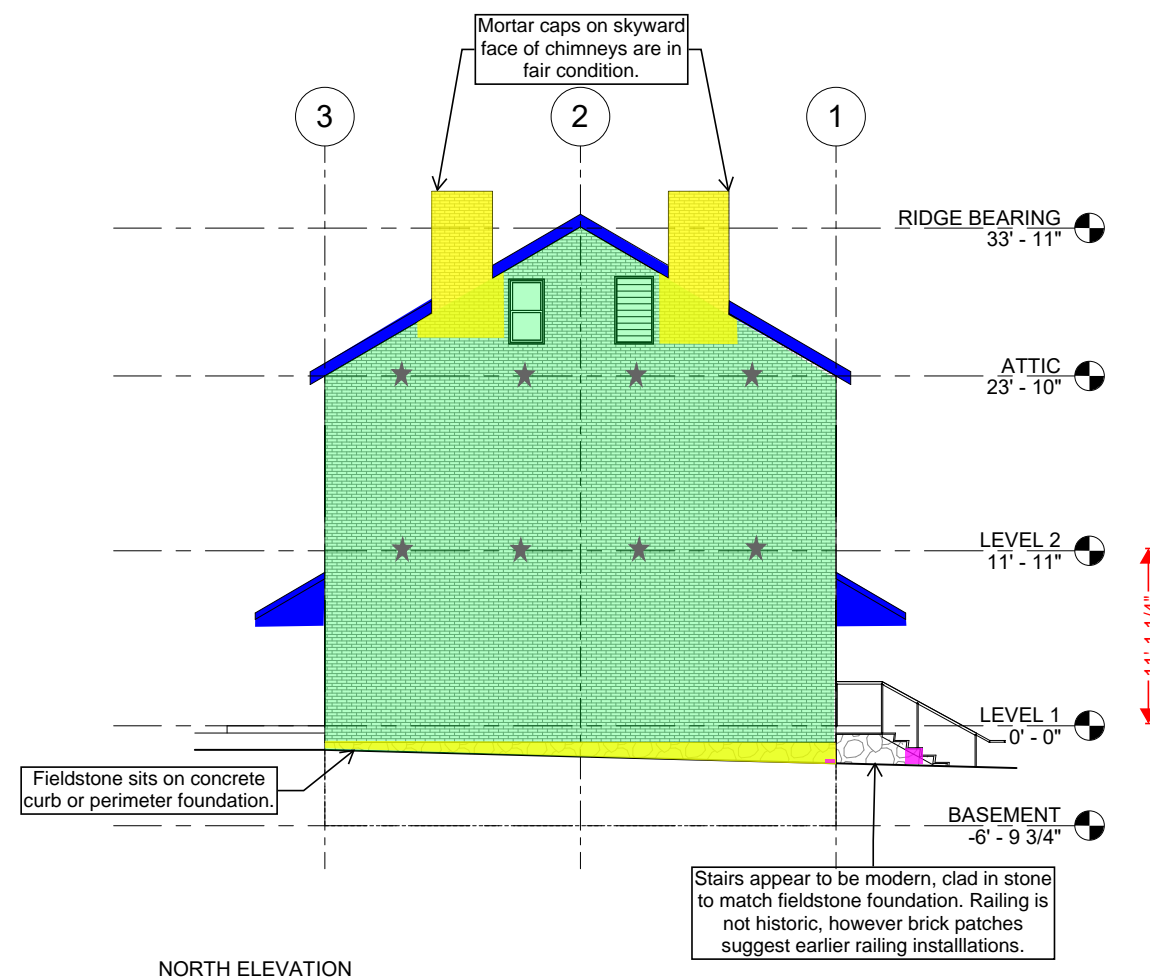
- The roof shingles show signs of lifting, curling, and heavy weathering.
- Flashing is visible below sills.

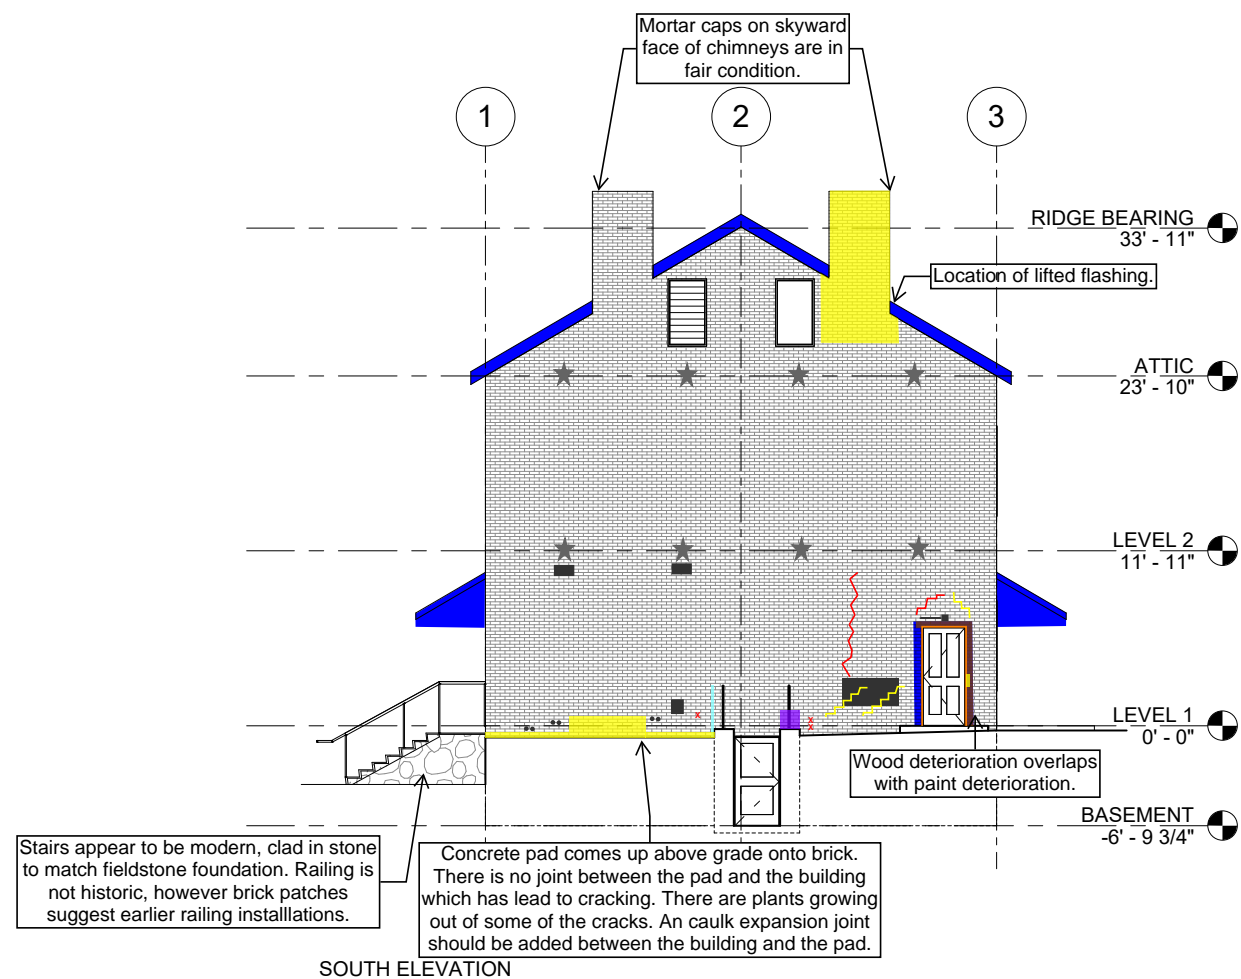
Note that right chimney was rebuilt in the 1970s

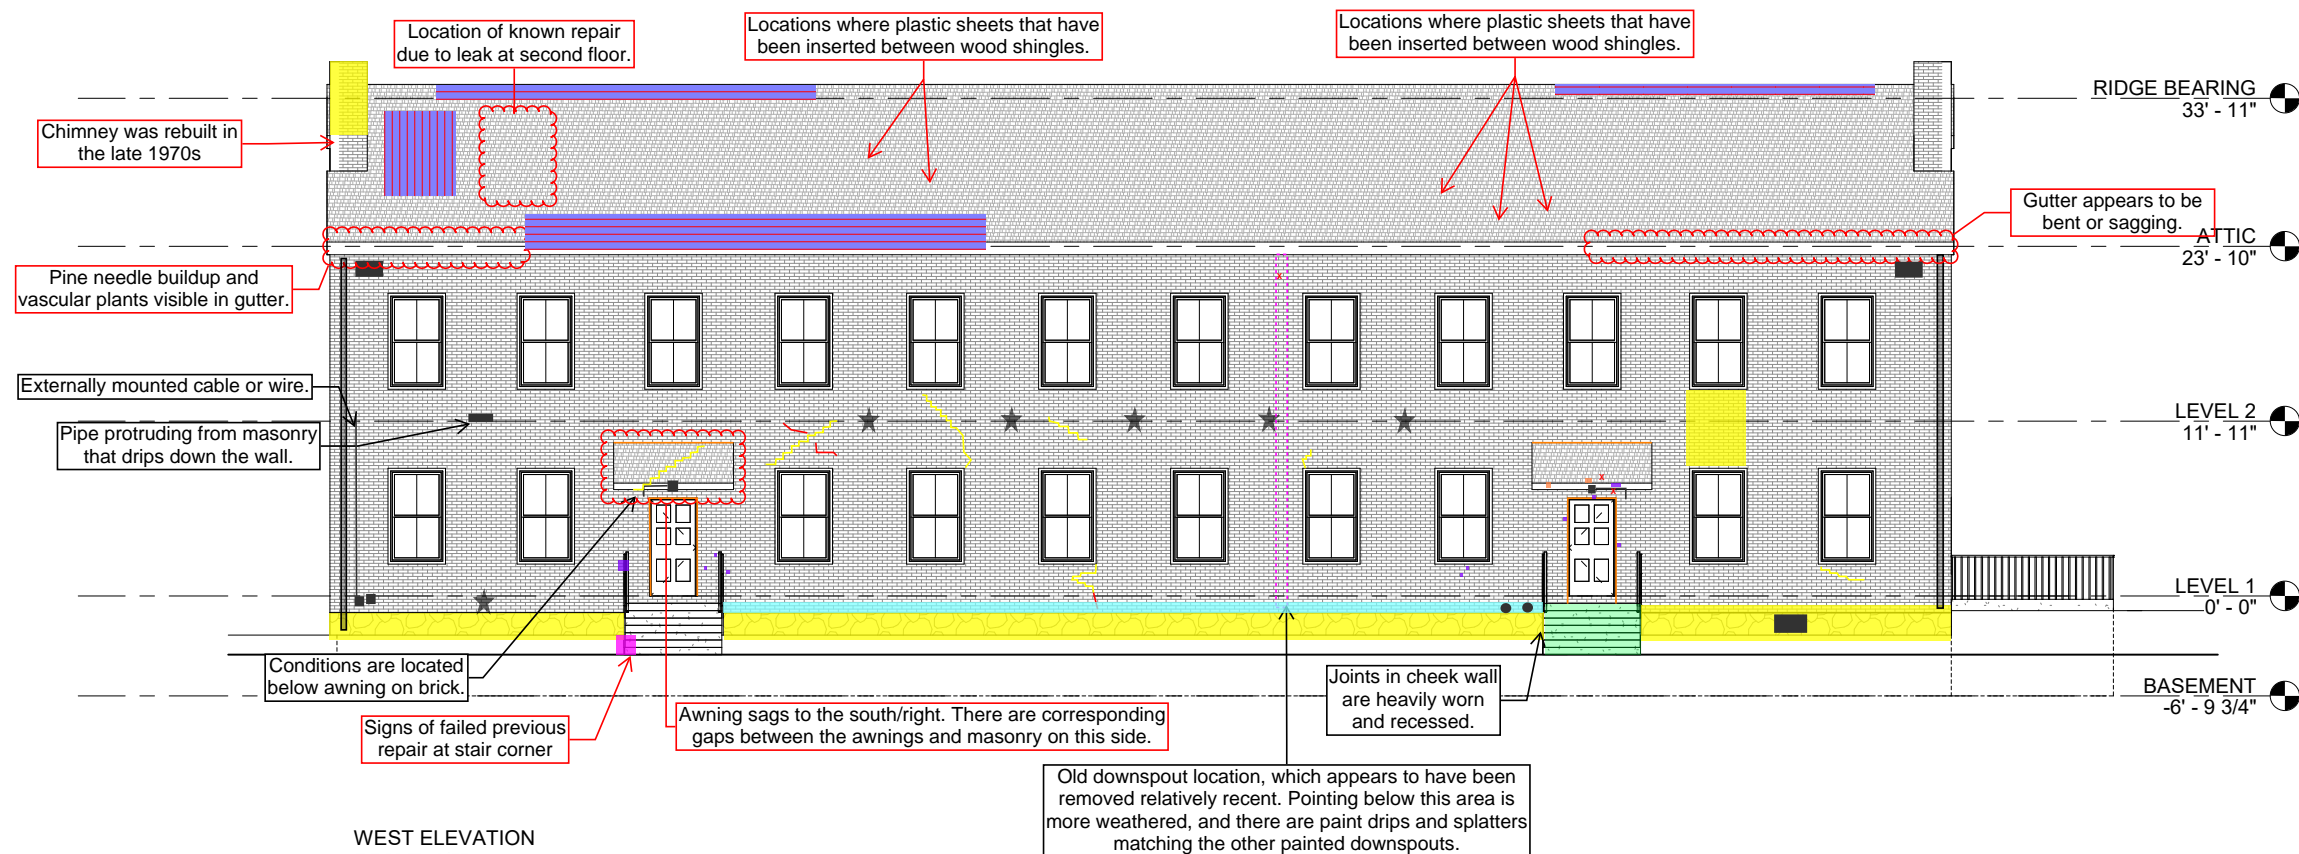
**Legend of Conditions and Repairs**

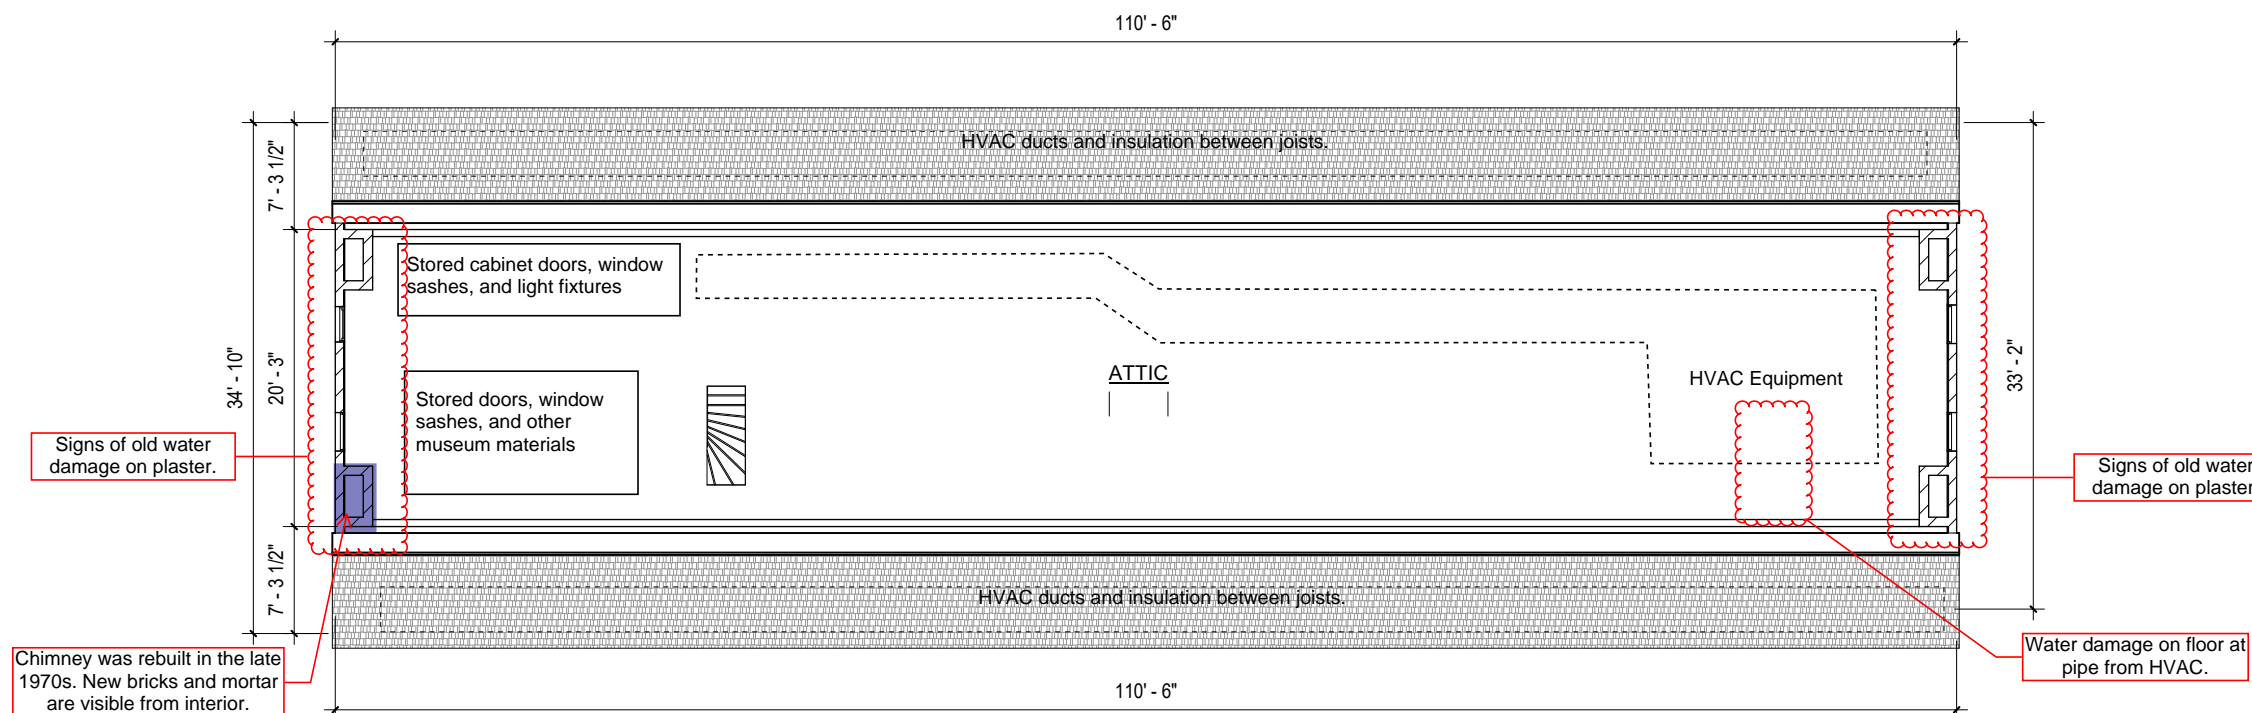
- The roof shingles show signs of lifting, curling, and heavy weathering.

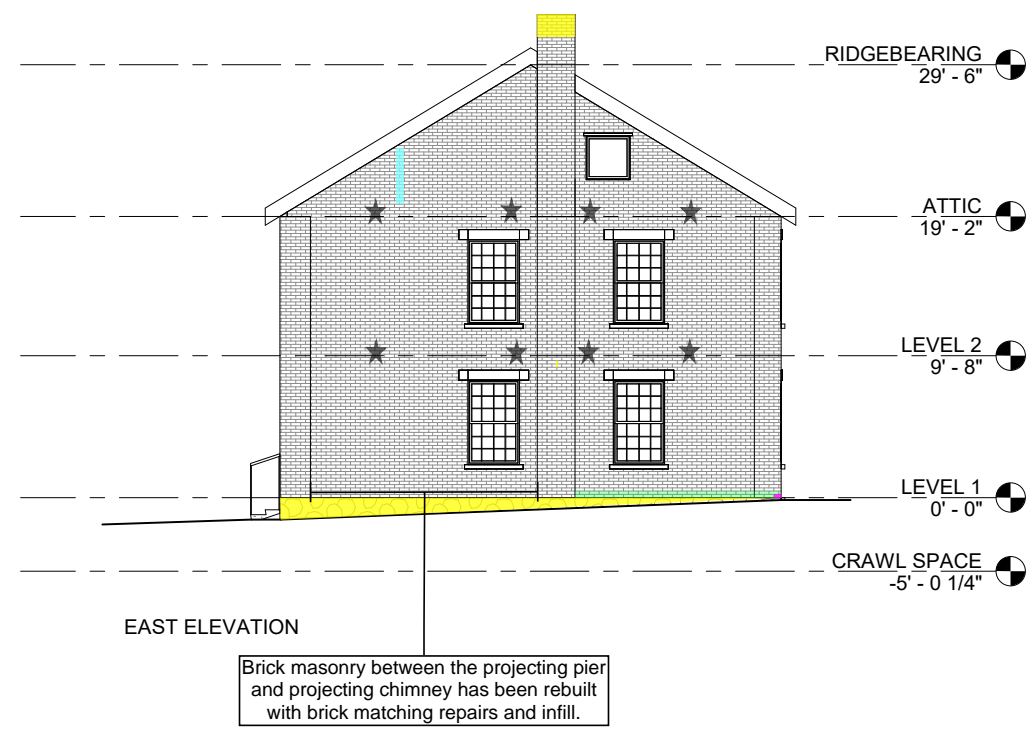
**Legend of Conditions and Repairs**

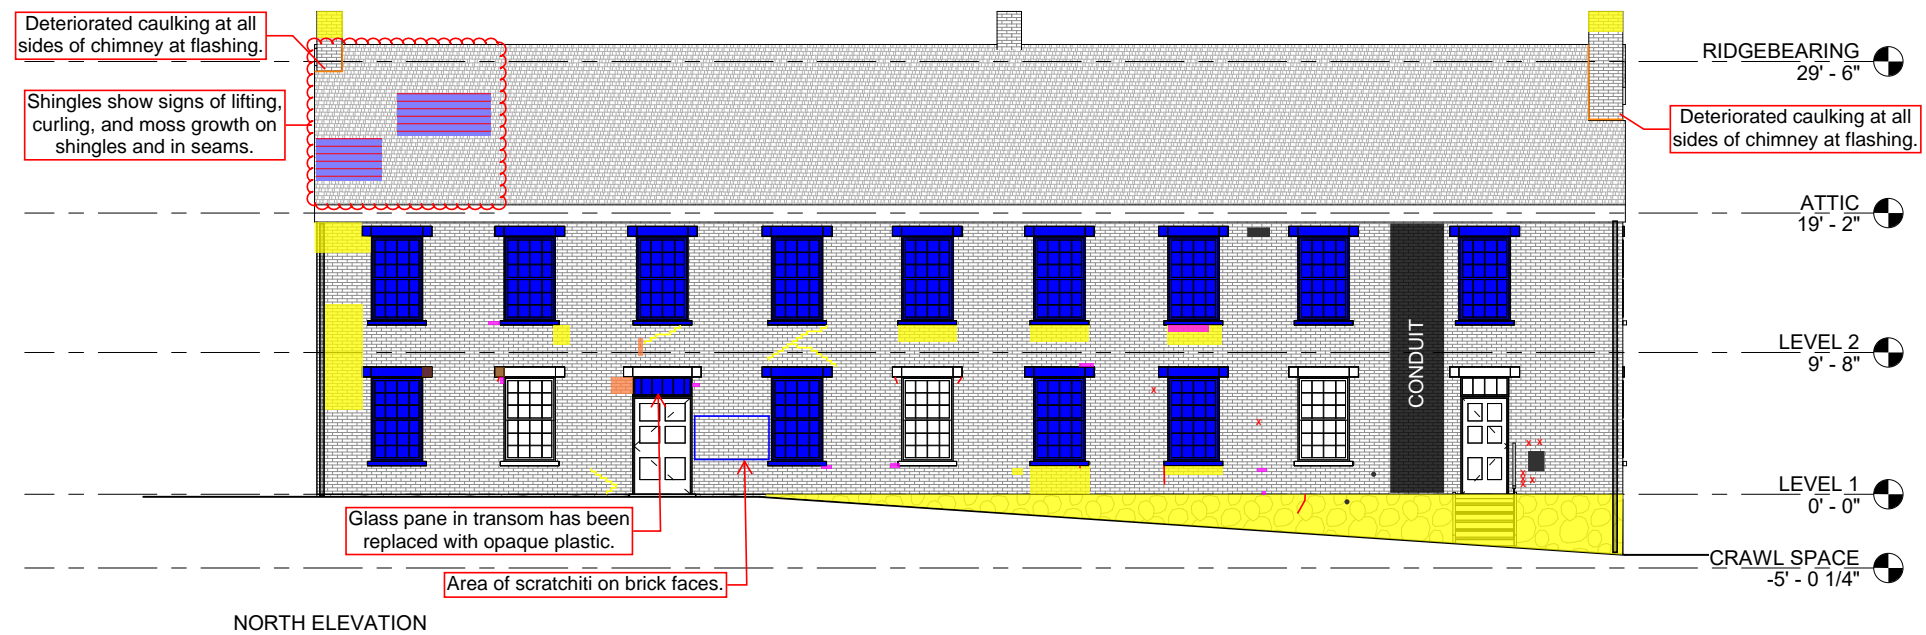
- There are multiple areas of brick infill that vary in size from single bricks to the spandrels between windows. The brick is a good match for the existing brick, with slightly less color variation than the original.
- The brick is laid in a common bond pattern with variation in the number of stretcher rows between header rows. The variation on the right side which is presumed to be original at this time, is carried over in to the rebuilt section at the left.
- white paint, likely from repainting the window frames and trim on the building.
- Open joints in the fieldstone vary and can be very large in size.
- Mortar caps on chimneys are in poor condition and should be replaced during repointing.
- Window sashes and surrounds including lintels and sills are new.

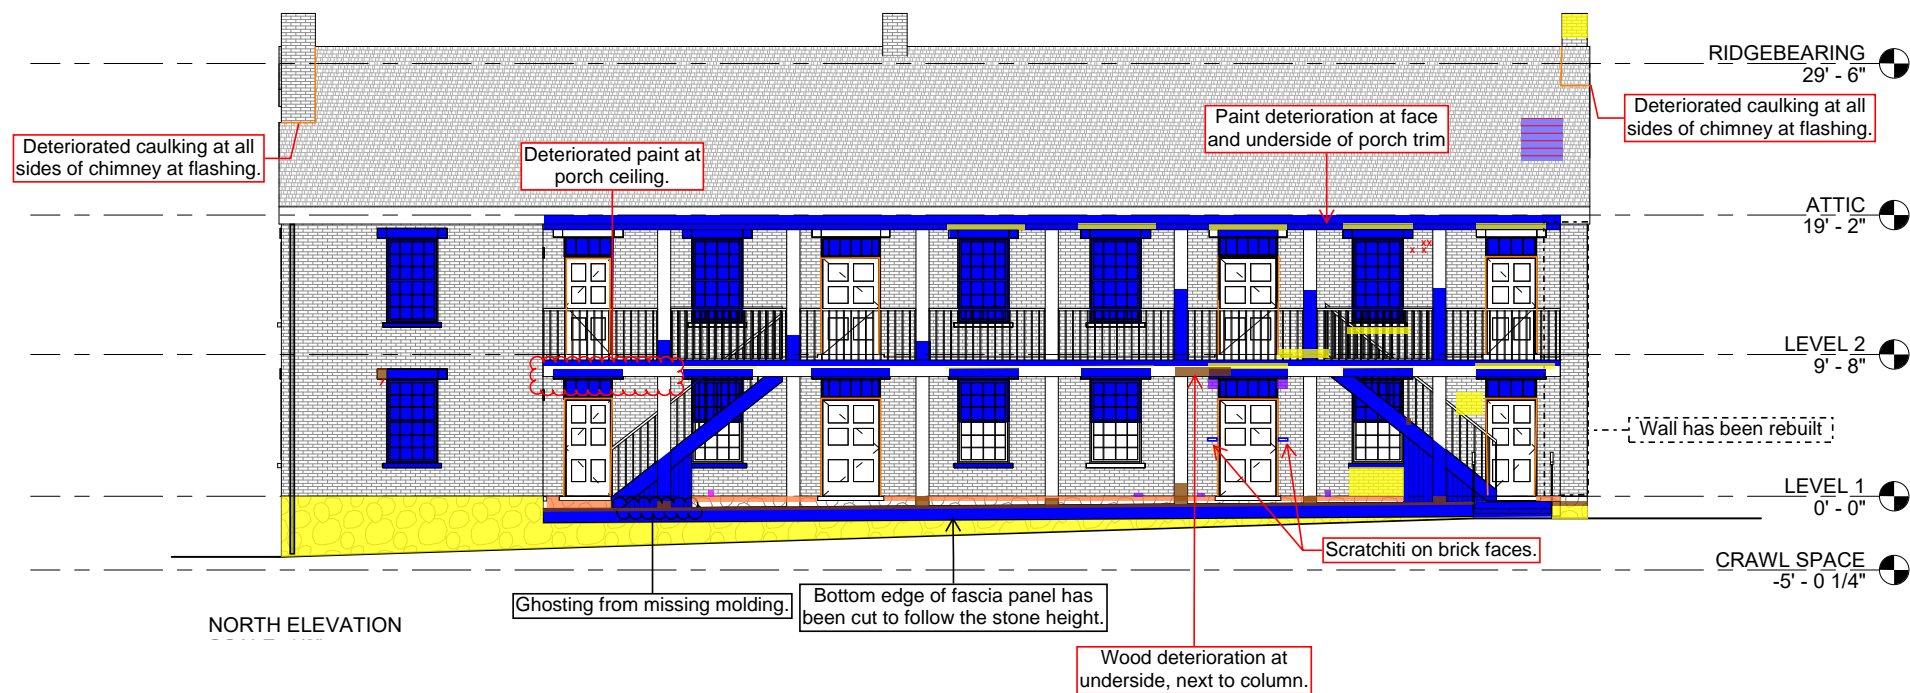
- Mortar caps on chimneys are in poor condition and should be replaced during repointing.
- The roof shingles show signs of lifting, curling, and heavy weathering.

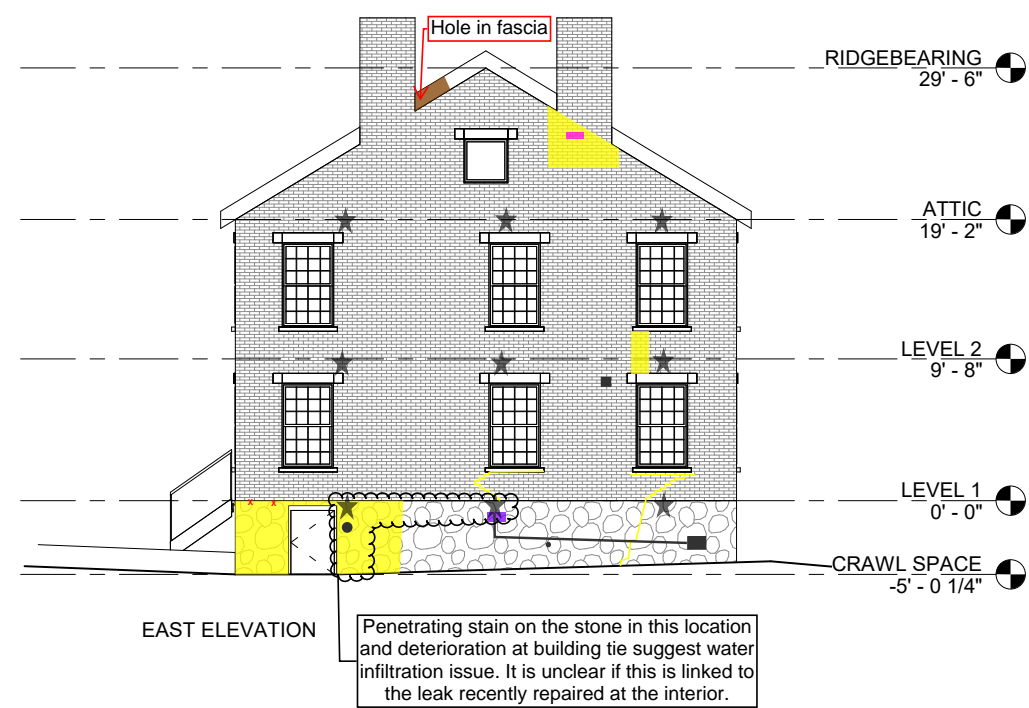
Legend			
Description	Quantity	Unit	
x Abandoned Anchors--Remove and Repair	2	Count	
Area for general repointing	58.19	sf	
Isolated Repointing	22.3448	ft	
Old Patch Removal and Replacement	0.82	sf	
Patch Repair	0.53	sf	
Utilities and Lights	2	Count	
Wood deterioration	2.60	sf

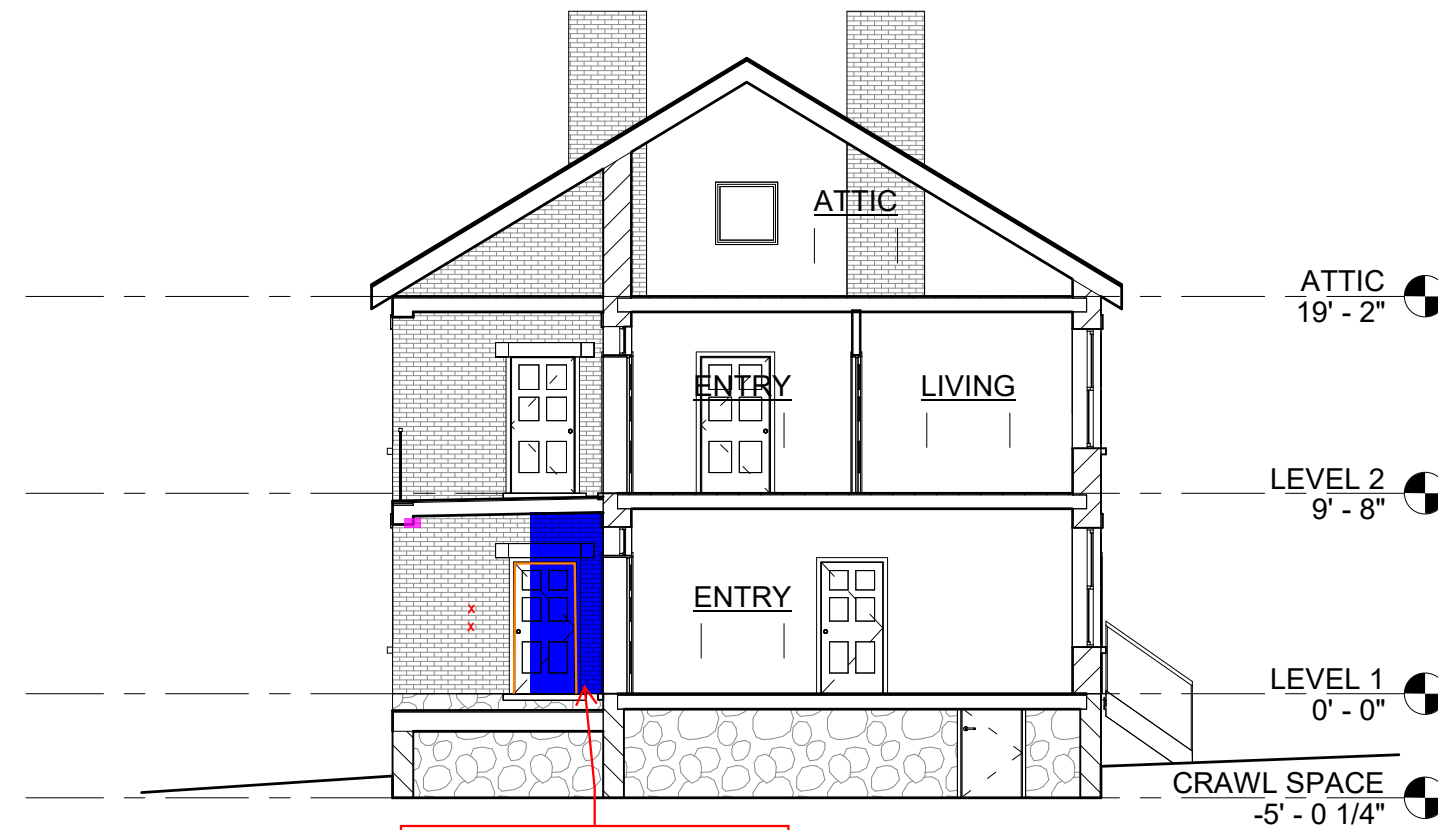
Paint deterioration at staircase.  
SECTION LOOKING WEST THROUGH LIVING

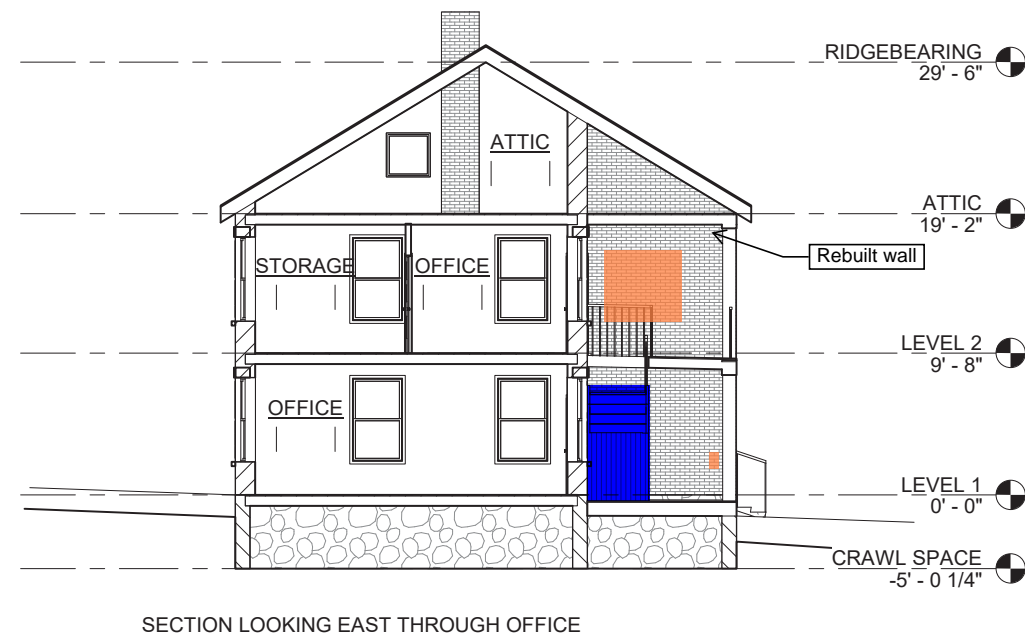
Legend		Quantity	Unit
Description
